**FIELD INVESTIGATION OF CAUSES  
OF FAILED WATER SUPPLY BOREHOLES  
AND PUMPING SYSTEMS IN IMO  
AND AKWA IBOM STATES, NIGERIA**

**WASH FIELD REPORT NO. 286**

**JANUARY 1990**

**Mike Webster  
and  
B. Johnson**

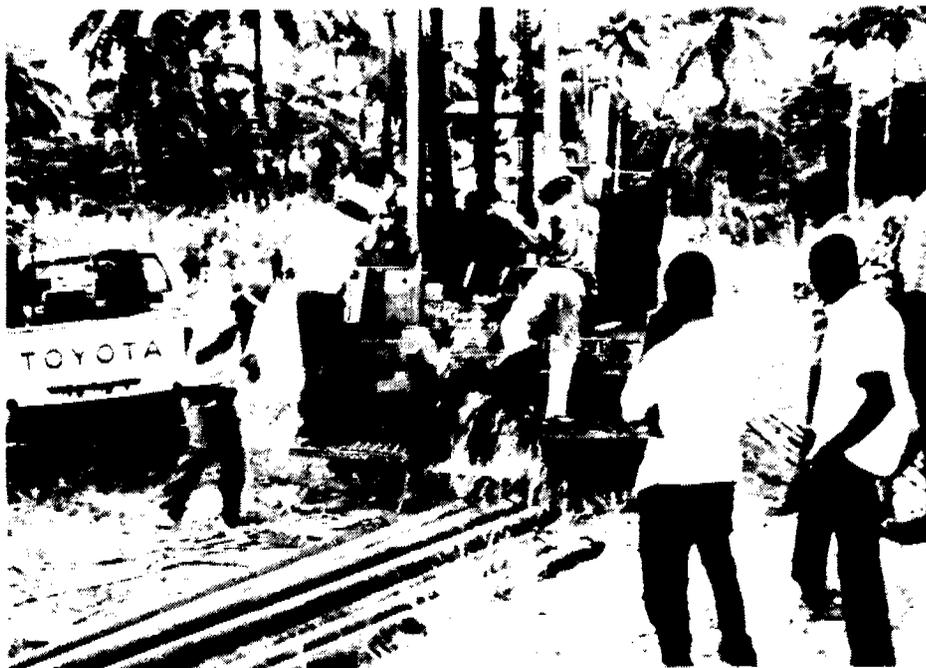
2. Removing the improperly sized 7.5 hp submersible pump at Umuelum

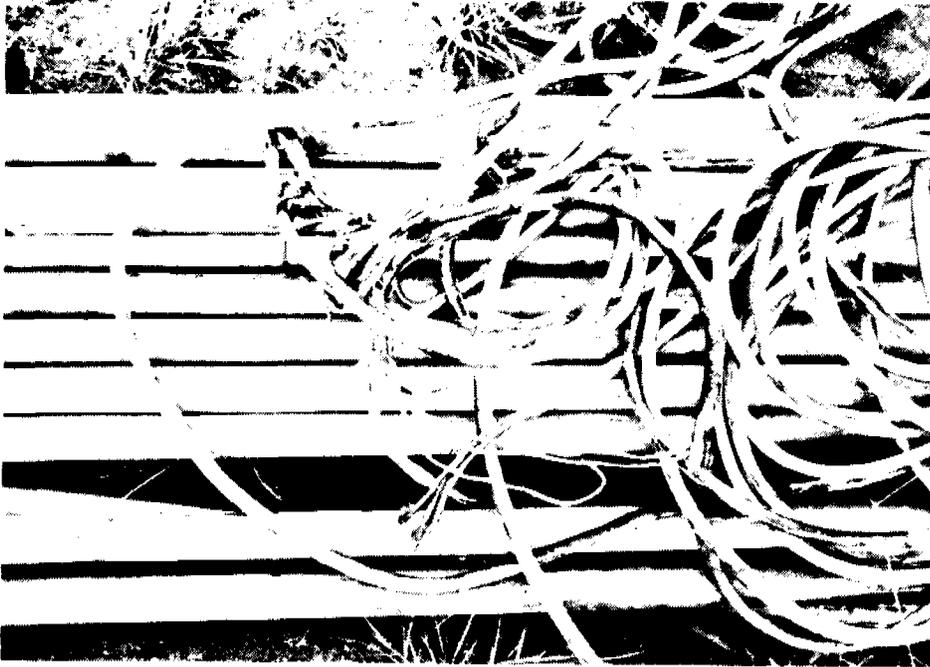
3. Electrical cable severely damaged,  
resulting from improper pump placement  
at Umelum

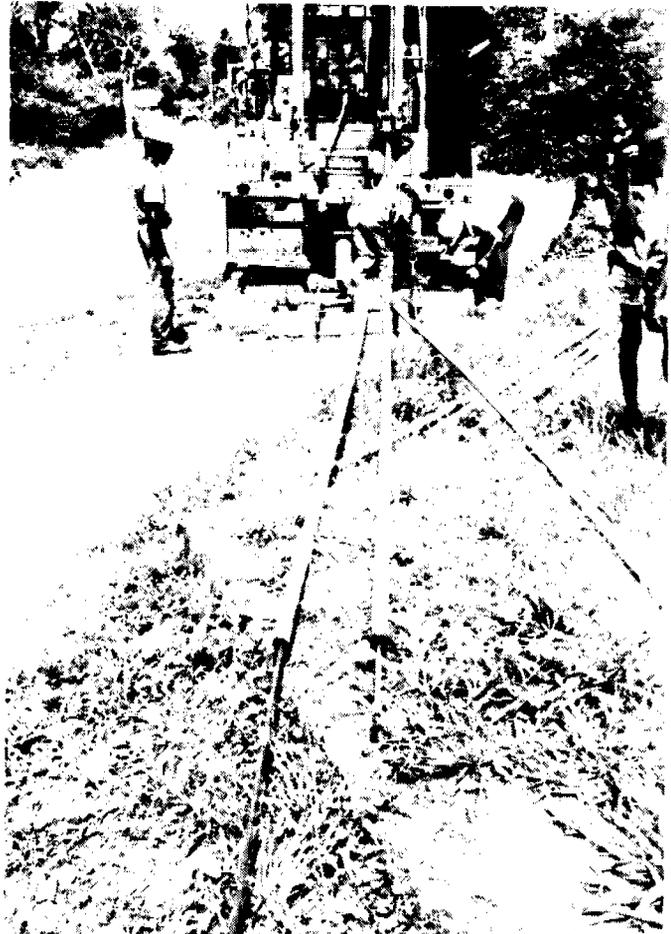
- **Remove and Inspect Pump.** Upon removal (from 70 feet) it was discovered that threads connecting the galvanized riser main to a coupler (at the second union, down 20 feet) were severely rusted through, causing water to leak from the riser main back into the borehole. The threads were stretched on one side, indicating that the riser main was pulled off center. When the pump cylinder was disassembled, the seals were completely worn--mostly on one side. The piston was severely worn and gouged, suggesting that a foreign object had fallen down the riser main and bound the piston movement. The lift rods were examined and found to be wearing on one side of the couplers (on each and every coupler). A visual inspection of the borehole (using a mirror) showed it out of plumb and

doglegged. The static water level was taken at 43 feet. Only half of the water could be seen from the surface, indicating degree of the dogleg. The entire pump and riser main were very discolored and thickly coated with rust. The villagers watching the inspection complained that the water was no good because of its color and taste; they also complained that the water would stain their clothes.

8. The removed India Mark II handpump at Ntit Oton. Note: Rusty-colored riser main, resulting from riser main failure at a connection, with water running down the outside of the main becoming rusty.

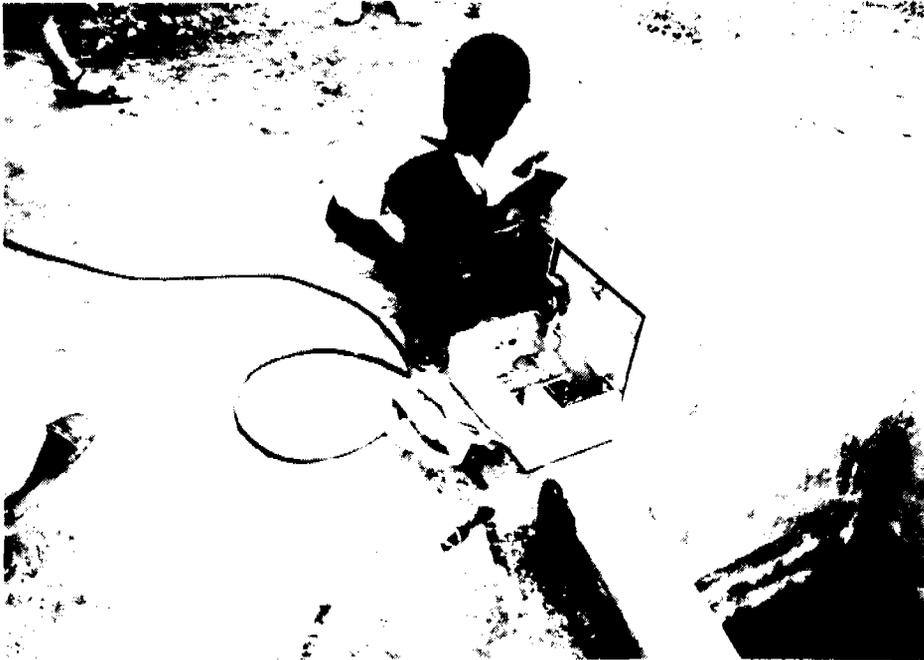
13. A pump suppliers' electrician trying to understand a complicated submersible pump starter box. He eventually succeeded. Note the deteriorated condition of the instruction pamphlet.

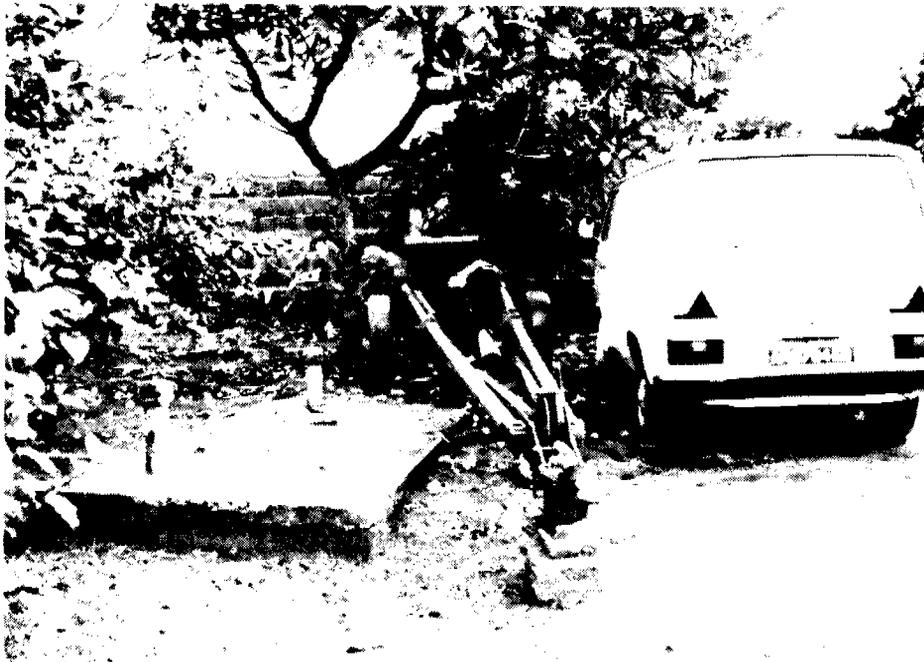
16. The very simple and inadequate cable tool percussion drill.
