*The Conrad N. Hilton Foundation 2017-2021 Safe Water Strategy¹, embraces the safe water challenge by driving impact at the district level in the six countries of Burkina Faso, Ethiopia, Ghana, Mali, Niger and Uganda. These impact labs provide the space to explore new solutions and expand approaches that already work well as a precursor to national and global implementation. Through this strategy, the CNHF and our partners bring the ambitions of SDG 6 within reach for households, health facilities and schools. **Similarly, the Watershed program** is focused on advocacy for improved WASH service access and Integrated Water Resource Management (IWRM). Both programs are keen on the availability of accurate and reliable WASH data availability for WASH service level and IWRM.*

With funding from the Conrad N. Hilton Foundation (CNHF) and Watershed programs, IRC Uganda supported Kabarole District Local government to undertake a service level assessment and an asset analysis in Kabarole District during July-August 2019.

The multi-faceted study had several linked objectives. The main objective of the service level assessment was to estimate the quality and type of services used by househo

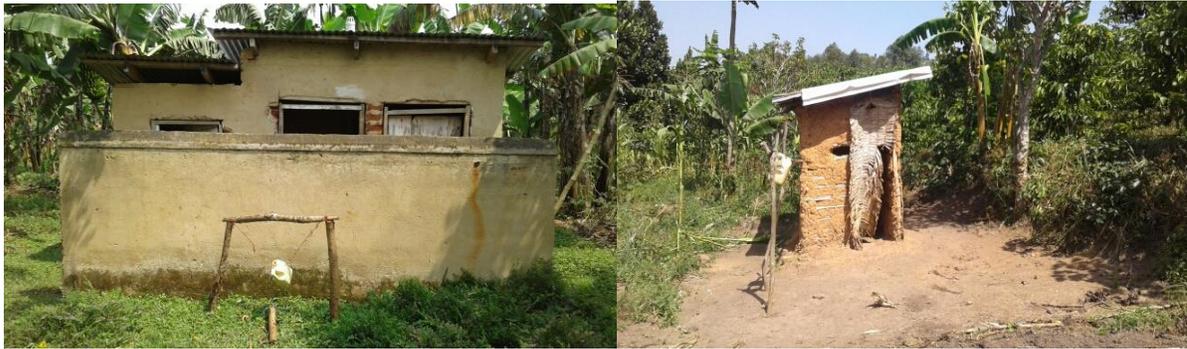
Ninety-four percent (678) of the households surveyed have sanitation facilities, while 6% (41) do not have sanitation facilities. Traditional pit latrines make up 95% (642) of 678 households, while ventilated improved pit latrines 5% (36). With regard to ownership of the latrines, 88% (600) were privately owned whilst 12% (77) shared by multiple households.

Figure 6: Left: A Privately owned VIP at Ntezi village, Kahangi parish, Hakibale S/c. Right a traditional pit latrine in Rwensenene village, Adiaga parish, Kabende both communities exhibit an understanding of basic sanitation.

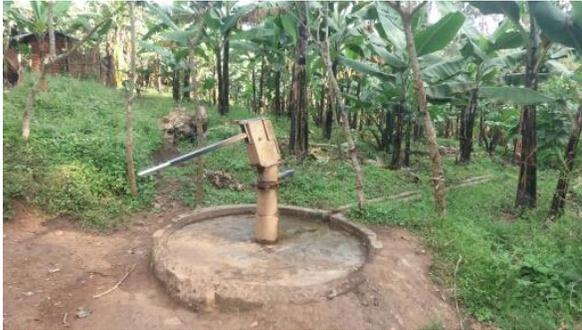
Type of Source	Number	U2	U3
Deep Borehole	43	35	8

Figure 12: Kigumba Deep Borehole fitted with U2 hand pump in Kirangara village, Kicwamba Subcounty.

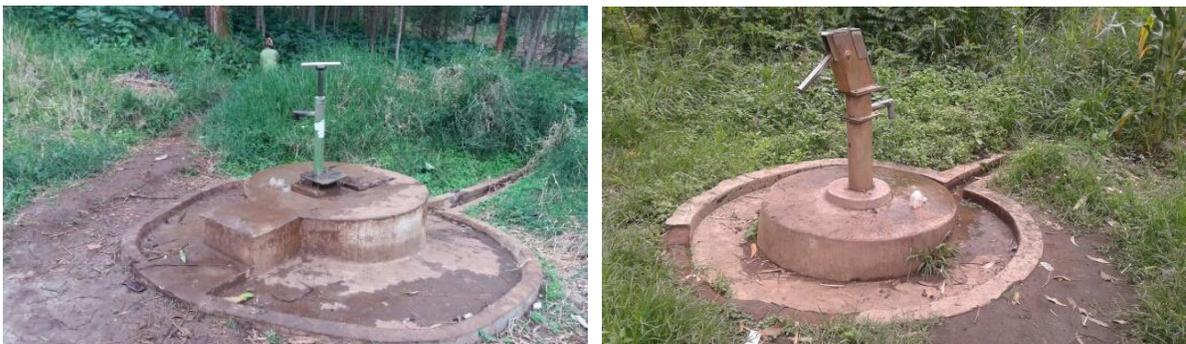
Four types of hand pumps were found installed in shallow well: - Nira Pumps, Tara Pumps and India Mark 2 Hand Pumps and India Mark 3. Majority of the shallow wells were recorded to have India Mark 2 and India Mark 3 hand pumps.

Figure 13: Shallow wells fitted with Nira pump (left) and India Mark 2 hand pump (right) in Karambi Village, Karambi Sub County

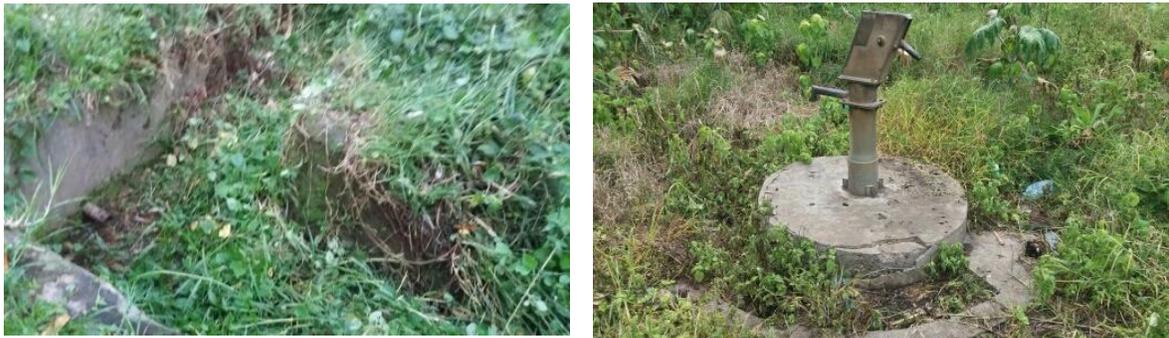
Tap stands were found to be most non-functional(51.3%) followed by deep boreholes (48.8%). This could be attributed to lack of skilled labour to repair these facilities, another possible reason could be the high cost required to maintain these facilities. Shallow wells and protected springs on the other hand were found to be more functional , 65.8% and 87.3% respectively. This is likely attributed to the low cost of repairs.

Figure 16: Left is a decommissioned protected spring in Burongo Village, Kihondo Parish, Kichwamba Sub County. Right is a decommissioned Shallow well in Bukoni, Rungwajo, Busoro Sub County. Out of the 337 non-functional sources, the primary reason reported for non-functionality was technical failure which was recorded for 84.6% of the non-functional sources. Dry wells or low yield accounted for 13.9% of the non-functional sources.
