Water, Sanitation and Disability in Rural West Africa

**Enhancing Access and Use of
WASH Facilities**

**A Summary Report of the Mali Water and Disabilities Study
March 2010**

Prepared by
W. Ray Norman, Ph.D.
Dean, School of Mathematics, Engineering and Business
Messiah College

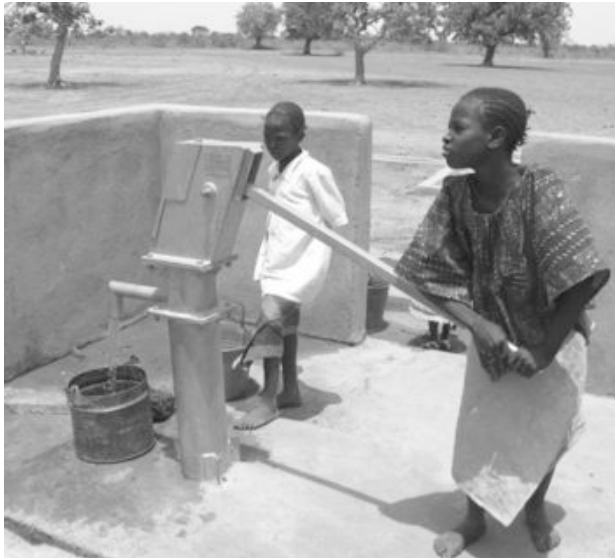
Figure 1.4 A typical hand-pump and superstructure facility of the Mali Rural Water Project

WAWI interventions in the WASH sector generally involve the development of boreholes, equipped with India Mark II hand-pumps and a surrounding, concrete superstructure often including a raised platform, apron, protective

walls and a separate laundry apron (figures 1.4 and 1.5). Sanitation facilities are generally developed around the dome-shaped, concrete sanplat latrine platforms (figure 1.6). While there are many other types of hand-pumps, superstructures and latrine facilities being employed in WASH programs around the world, the Study limited its work to facilitating access by the disabled to these technologies presently being used by WAWI. The Study also limited its work to exploring design enhancements which involve little or no increase in overall costs associated with the standard hand-pump, superstructure and latrine development packages used by WAWI.

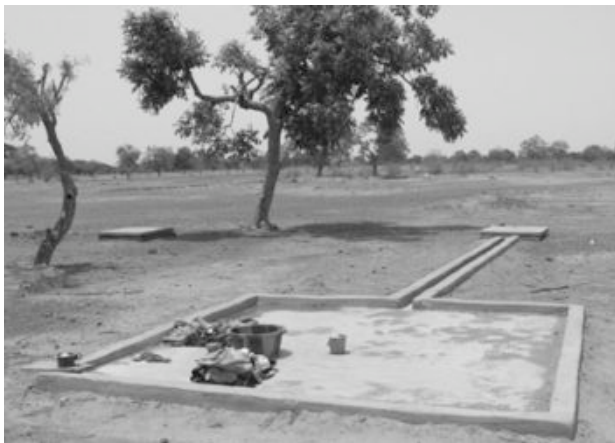
Figure 1.5 A typical laundry apron, usually placed within a few meters of the pump, which provides a convenient and hygienic place for clothes washing.

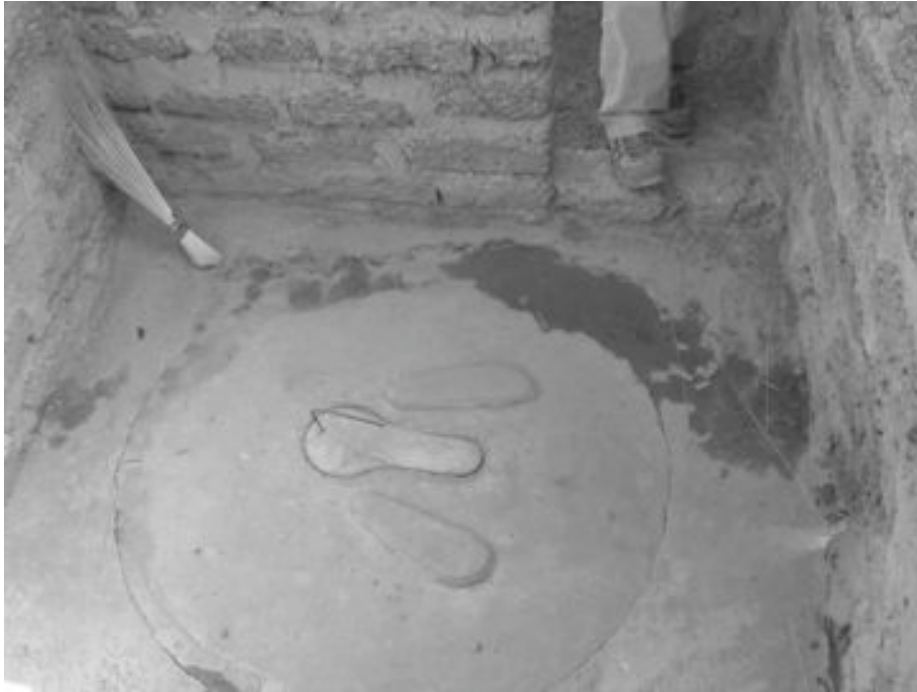
Figure 1.6 Sanplat latrine platform promoted by World Vision Mali's WASH programs.

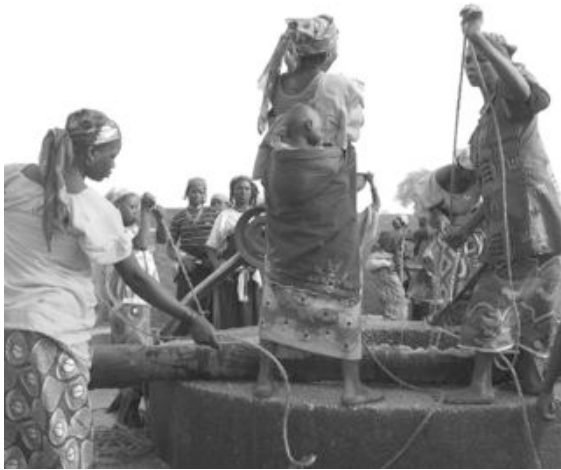
Figure 2.5 Typical open well in a village in Niger. The high usage and overcrowding, as well as the unwieldy infrastructure surrounding the well, makes access and use difficult for disabled persons.

In spite of boreholes and pumps being installed in many villages in the Tominian area, the survey indicated that the main water source for 88% of households is an open well, with only 11% of households indicating that pumps are their main source. For many this is simply a matter of convenience, as households may often have open wells within or adjacent to their household compound enclosure. For PWD who fetch water, some 95% indicated the most common source to be an open well, largely due to proximity and convenience to their places of residence (figure 2.5).

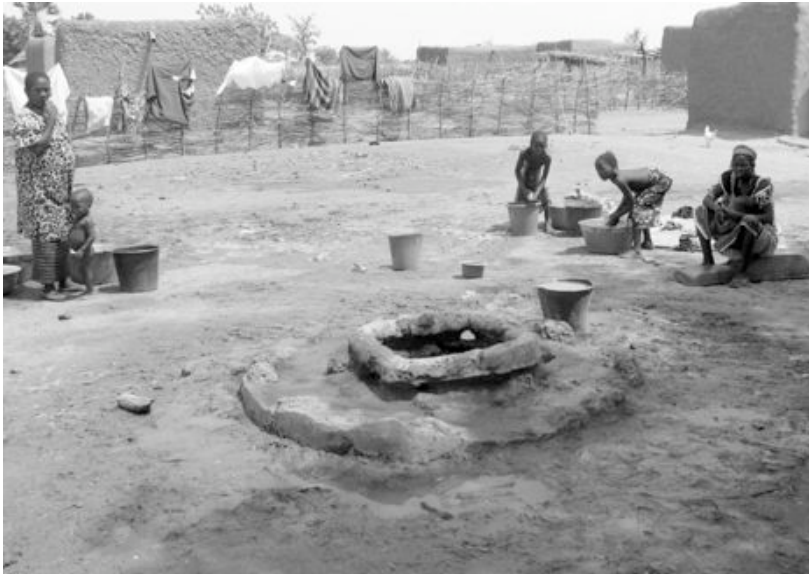
Figure 2.6 Traditional village well in south-central Mali. Note the poorly constructed apron and the standing water and mud surrounding the well.

Regarding improvements for wells, PWD suggested the installation of concrete aprons to reduce mud and water around wells (figure 2.6). Many disabled persons find stability difficult in wet or muddy ground. Others with lower-body limitations must sit on the ground while drawing water from wells. Other suggestions included the installation of permanent seats adjacent to the well, pulleys to aid water withdrawal, and lower protection walls to facilitate well access by PWD.

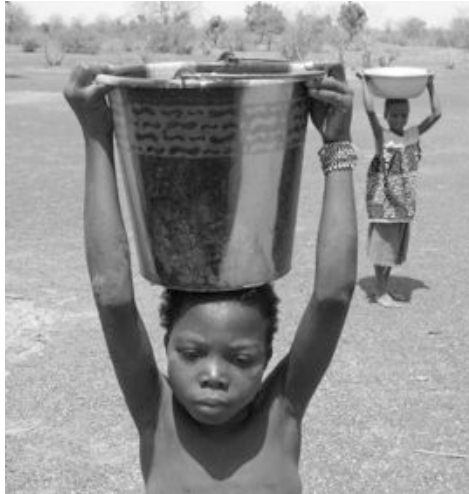
Figure 2.11 *Young girls carrying water with open plastic bucket and aluminum basin containers. Note the wide rims, which facilitate grasping.*

larger 20-25 jerry can (“bidon”), while women preferred the larger aluminum basin (see figures 2.11 and 2.12 for examples). As has already been mentioned earlier in the report, plastic buckets (15-20 liters) are relatively low-cost and have a wide rim which facilitates lifting it to the head for transport. The larger open basins (20-25 liters) also have wide rims which facilitate lifting, but due to the added weight, the user often needs assistance from another person to lift it to the head and to lower it once the user has arrived at the place of residence. One negative aspect is that they often incur spillage during transport. Plastic jerry cans (or “bidons”, 20-25 liters) have small mouths with screw-on caps. These are preferred by many male users and some females (usually young adult females). These do not incur spillage, but are more difficult to lift and lower due to their smooth sides and heavy weight when full. Younger and elderly users may often bring an assortment of other smaller volume containers.

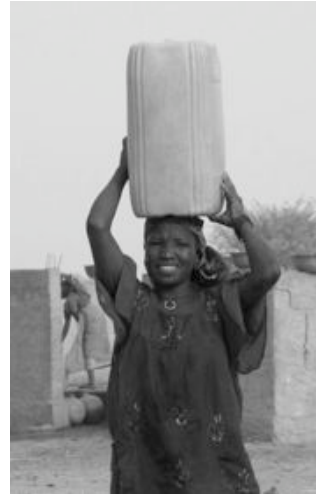
Figure 2.12 *A woman using a 25 liter plastic jerry can ("bidon") to carry water. Note the straight sides and absence of convenient handles.*

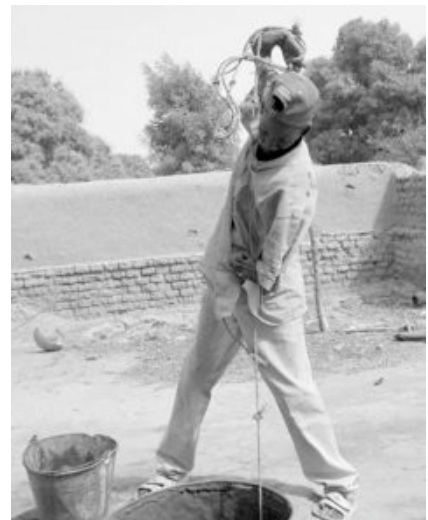
Figure 2.13 *This young man, born with short forearms, demonstrates how he draws water from the family well.*

Of the PWD who fetch water, most (90%) draw or pump the water themselves (figures 2.13 and 2.14). For those who do not draw or pump the water, nearly half reported the challenge of not being able to hold themselves in a stable position to draw with a rope and bucket or to manipulate the pump handle. Many of these are persons with lower-body disabilities. Others reported lack of upper-body strength to lift or operate the pump handle or the inability to mount the apron or platform surrounding the well or pump. These who do not draw or pump water for themselves report the need for assistance from others at the water source to fill their containers.

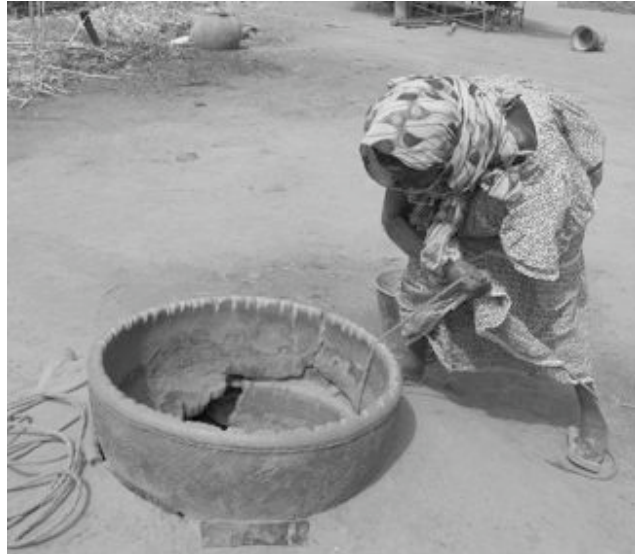
Figure 2.14 This woman with limited use of her left side (both arm and leg) demonstrates how she lifts water with her right arm, and then uses her weaker left foot to hold the cord after each lifting motion.

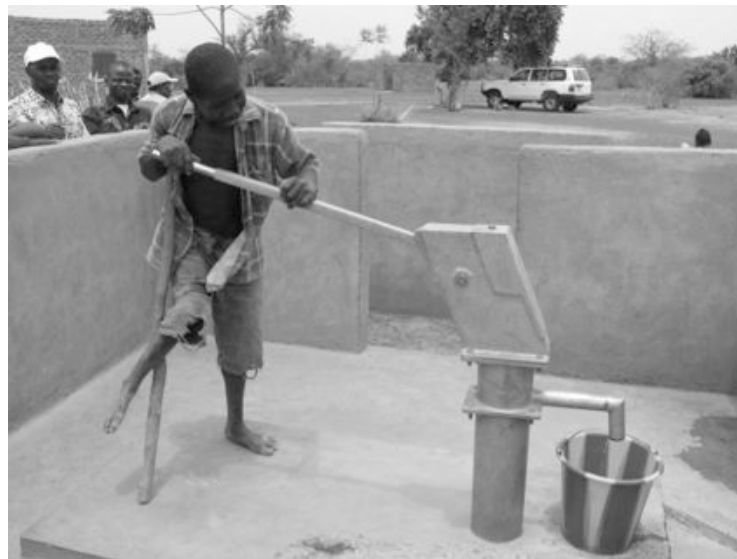
Figure 2.15 A young disabled man trying to simultaneously pump and hold himself upright with his cane. In this position, he is unable to produce a steady flow from the pump.

Only 6% of all interviewed PWD reported using hand-pumps themselves. Most of these also reported the need to use two hands for pumping so as to stabilize themselves in an upright position (figure 2.15). A few PWD reported challenges of removing containers from under the water outlet of the pump and of lifting the full containers.

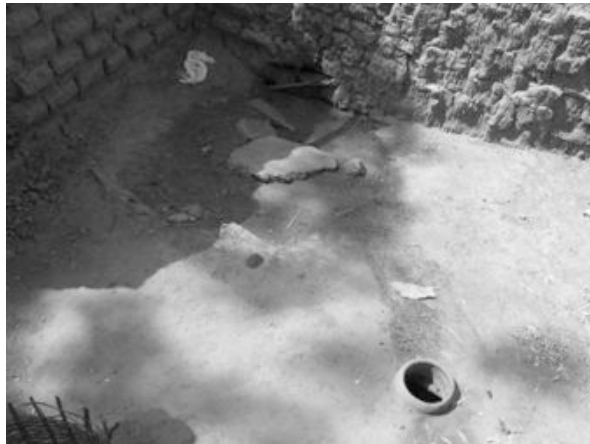
Figure 2.20 A typical traditional latrine in Mali. Note the circular rim of a clay pot used to line the latrine hole. The rock slab near the drainage hole in the upper part of the photo is the area typically used for bathing. Use of latrines and bathing areas pose special physical and hygienic challenges for disabled persons, especially if the floor is muddy, poorly drained or unkempt by the rest of the household.

In this part of rural Mali, more than 60% of households report they have no latrine. Approximately 35% or less of households have traditional latrines, (figure 2.20) with about 5% reporting they have some form of improved latrine such as the sanplat (figure 1.6). Fifty-eight percent of PWD report either not having or not using a latrine, with most having to go outside their place of residence to relieve themselves in adjacent fields or the bush.⁸ In the wet season, PWD report they do not have as far to walk as they often use the crop fields adjacent to their residence for privacy, although at this time they may face the challenge of mud or water

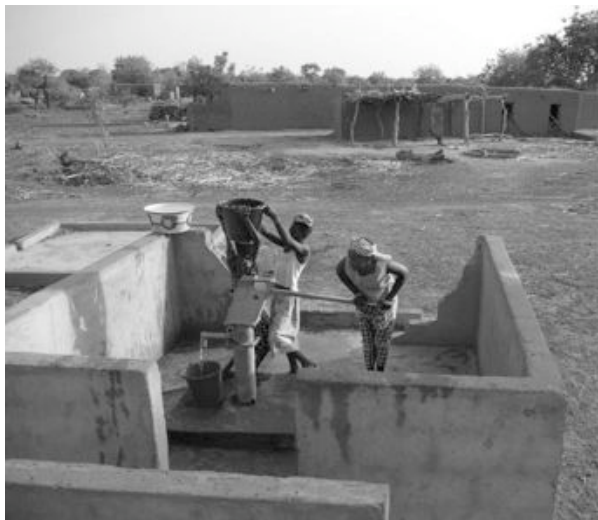
Figure 3.1 A WAWI-MRWP hand-pump at Yasso, Tominian region, Mali.

Tominian area with a population of about 1,000, largely of “Bwa” ethnicity. The water table in Yasso is at about 15 meters, and the pump is outfitted with a single, straight handle (figure 3.1). Since the village has multiple sources of water, the use of the hand-pump is generally one of convenience or user preference. Pump monitoring took place in the month of June during the

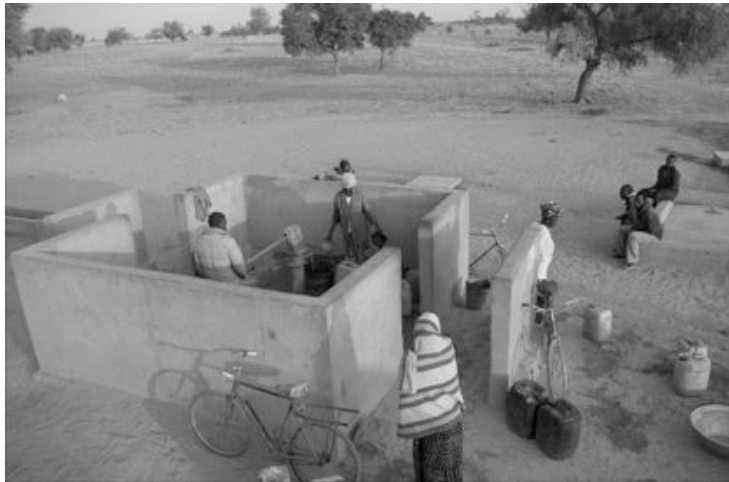
Figure 3.2 A WAWI-MRWP hand-pump at Gama, Koro region, Mali, equipped with weighted T-handle.

region’s hottest season. The second village, Gama, is located in the more arid Koro region of Mali with a population of about 600, mostly of “Dogon” ethnicity. The water table in the area ranges from about 60-80 meters, and the pump is outfitted with a weighted T-handle to facilitate water lifting from such depths (figure 3.2). Gama has no open wells (the nearest being some 6

handle design also lets the user stand at the end of the pump handle while pumping, in a more comfortable two-handed grip (figure 3.2). For shallower wells, however, this T-handle is too heavy and would make the pump mechanics worse for the user.

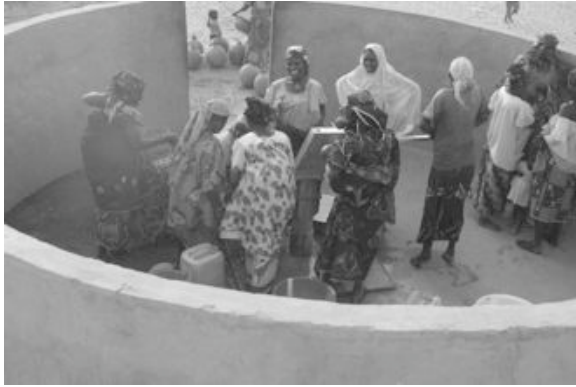
Figure 3.9 A typical WAWI hand-pump in Niger. High use, crowding and long waiting times can be a disincentive for pump use for many disabled persons.

which then may mean longer waiting times at the pump for the disabled (figure 3.9).

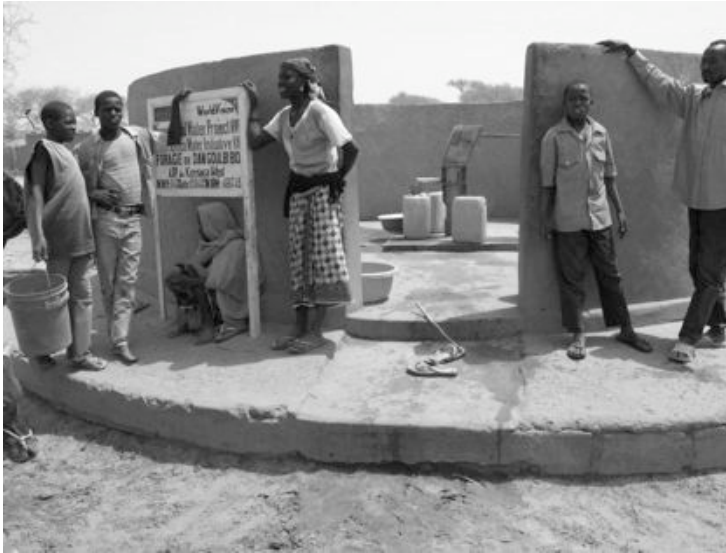
Figure 4.1 A hand-pump and protective superstructure in Niger, with two entry steps and a pump support platform inside the enclosure. A disabled member of the community can find the three steps challenging to negotiate, especially when carrying a container full of water.

When arriving at the superstructure, disabled persons often find the entrance step up to the pump apron or the step up to the pump platform to be a significant impediment, and even more of an obstacle when descending with a full container (figure 4.1). The use of a cane or crutches can actually increase the challenge and risk of negotiating even a small step. If the superstructure is not well-drained, wet floor surfaces can be slippery and dangerous for those with mobility challenges and will soil those who must walk using both hands and legs. Those using a manually-powered tricycle must dismount with their container adjacent to the superstructure and traverse ground which is often wet or very hot (a major challenge if walking on all fours). Upon reaching the superstructure they are required to negotiate the various steps and platforms, fill their containers and re-negotiate these obstacles with a full container.

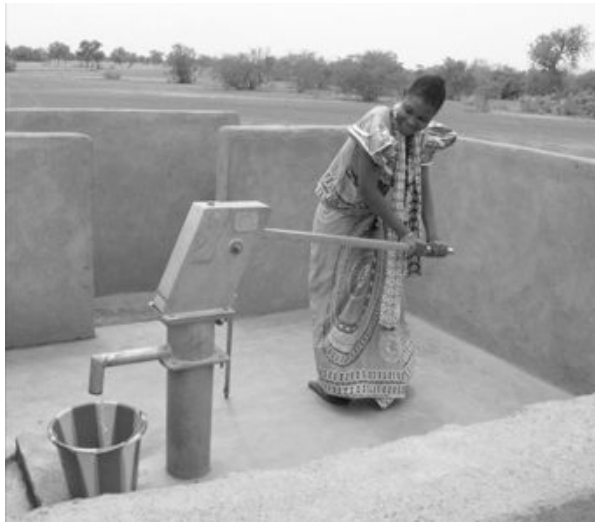
Figure 4.2 This young mother and polio victim can only walk with the aid of crutches, but she uses the pump handle to steady herself, freeing her hands for pumping. She is unable, however, to produce a steady pump flow because much of her strength is used to stabilize herself, leaving little strength for stroking the pump handle.

strength on manipulating the pump handle (figure 4.2). Others find the concrete pump support platform too narrow and face the possibility of slipping or stepping off the edge while trying to pump. Those who cannot stand upright must sit on the ground and reach up to the handle for pumping. Pumping in this position does not provide sufficient leverage to adequately manipulate the pump handle for sustained periods, often resulting in fatigue. Furthermore, sitting on the ground often results in the disabled person becoming soiled and wet (figure 4.3).

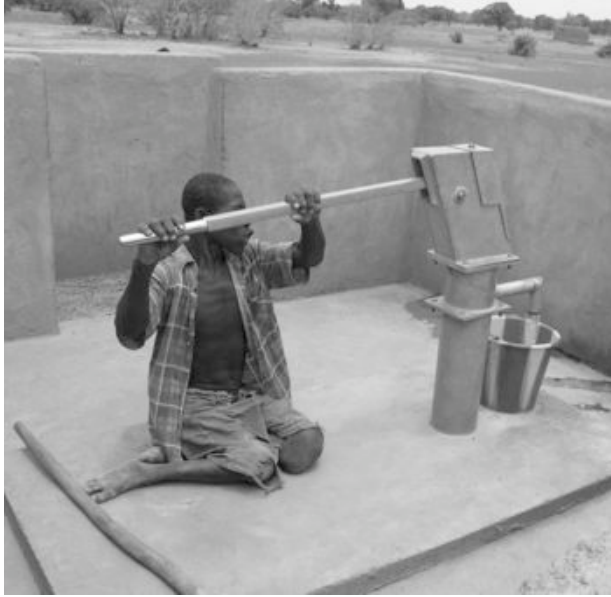
Figure 4.3 This young man finds that he gets more leverage for pumping by sitting on the ground than by staying erect with the aid of his cane. However, since his leverage on the handle is not good, he still struggles to maintain a steady flow rate. At times, the platform floor may be wet or soiled when he comes to use the pump.

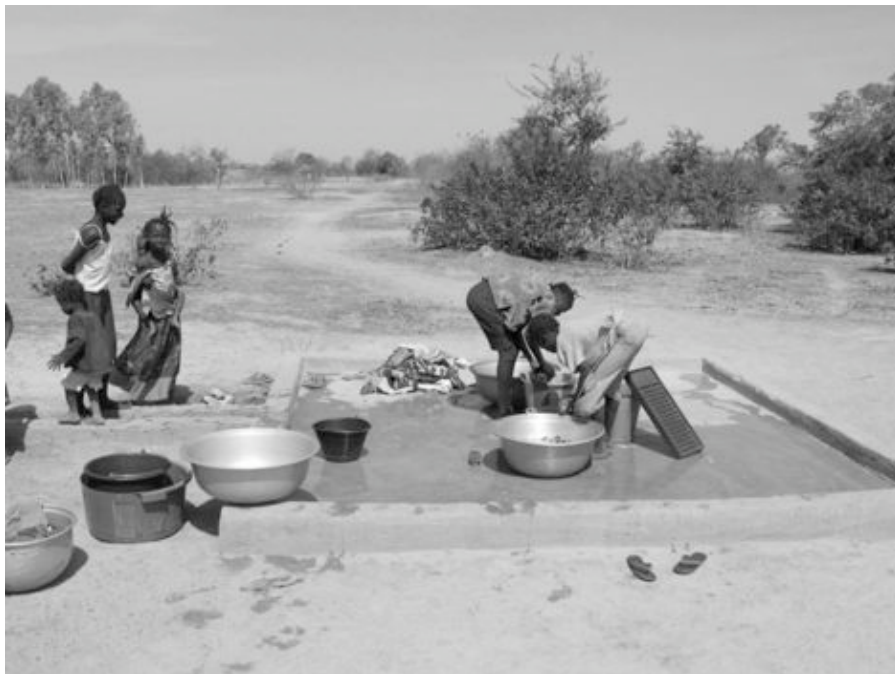
Figure 4.5 A well-used laundry apron in Mali. Many disabled persons are unable to stand and wash their clothes and must sit on the ground or on available seating. This apron provides no functional seating above the wet floor.

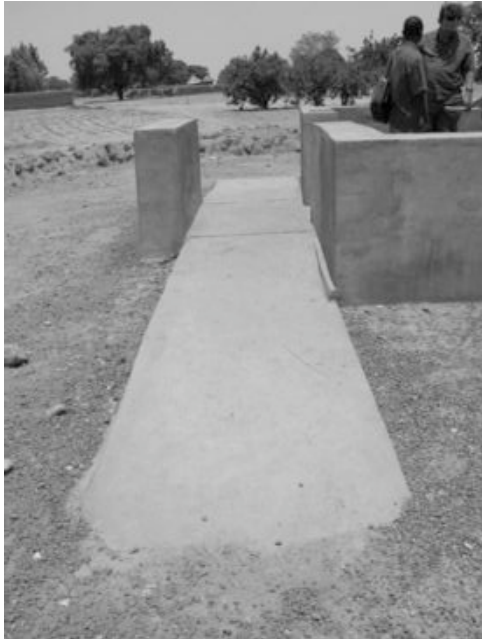
Figure 4.6 Pedestrian and tricycle access and egress ramp for a pump superstructure. Note the two parallel depressions at the top of the ramps for stabilizing the rear and forward wheels of a parked tricycle.

Most entranceways to the superstructure require a step of 15-30 cm up to the apron level. The addition of a ramp on one of the entranceways can greatly facilitate access by disabled persons on foot or using a tricycle. The entranceway should have both an entrance and exit ramp, located between the entranceway protection wall and the enclosure wall, so as to facilitate the entrance and exit of tricycles (figures 4.6, 4.7 and 4.8). The level portion, between the entrance and exit ramps, should be at the same level as the enclosed apron and be long enough (at least 1.7 m) to park the tricycle while the user dismounts to pump water. Linear depressions of 1-2 cm depth running the width of the level portion at the top of each ramp and placed where the front and rear wheels will be stationary in the level portion can also

serve to prevent the tricycle from rolling down the ramp. There should also be sufficient ramp width (at least 1 m) to assure free movement of the tricycle between the entrance protection wall and the enclosure wall. Ramps should not have a slope in excess of 7% so as to assure that disabled pedestrians or tricycle users can easily ascend or descend. The adjoining entrance through the enclosure wall should be at least 0.8 m. (However, should this entrance be widened, then the external protection wall should be lengthened accordingly so as to discourage entrance of livestock and minimize the collection of wind-borne sand within the principal enclosure.) Design dimensions of the ramped entrance on the superstructure model developed by the Study can be seen in Appendix 1.¹³ It should be noted that this diagram in Appendix 1 only depicts the above-ground design; all ramps should be constructed with adequate foundations to reduce cracking and premature deterioration.

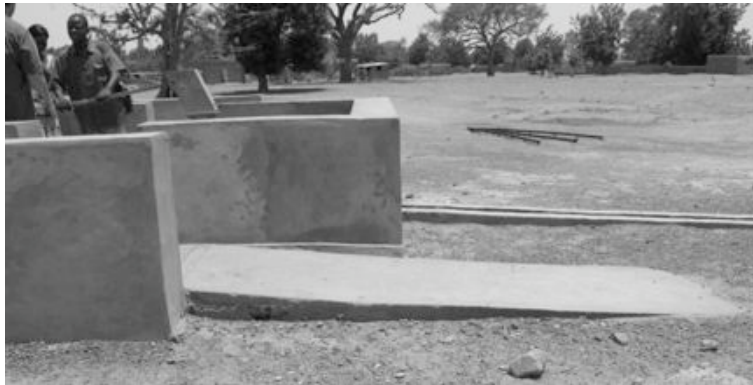
Figure 4.7 Side view of a pump superstructure access ramp.

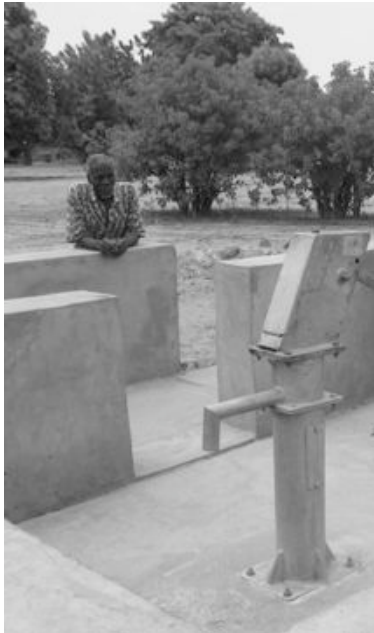
Figure 4.9 A pump superstructure apron filled to the same level as the pump support platform and the entrance ramp. Pump superstructures with no steps or abrupt elevation changes at the ground level can greatly enhance pump access by disabled persons. (Note: the shallow drainage channel running across the floor of the entranceway does not represent any change in floor level.)

platform so as to assure a completely level access area around the pump (although slightly sloped at 5% or less) (figure 4.9).

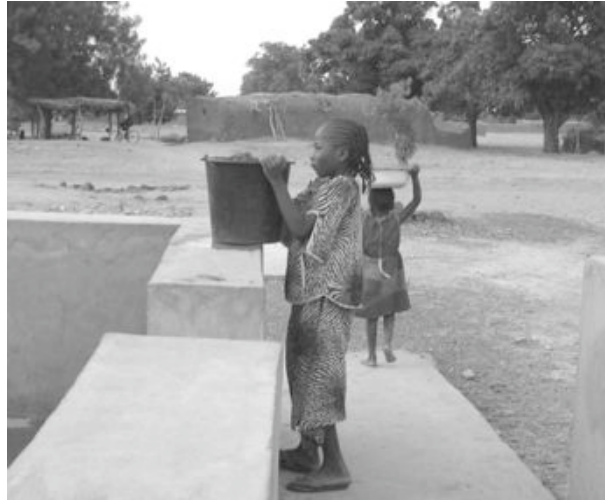
Figure 4.10 *By separating the lifting motion into two less strenuous steps, lower enclosure walls can be used to facilitate lifting heavy water containers to the head for transport (i.e., lifting from floor to wall, then from wall to head).*

help raise heavy water containers to the head of the user. Many women, and especially the disabled, need assistance from others when lifting heavy water containers to their heads in a single move. With lower walls, the user can first lift the container and place it on the top of the wall. Then she can reposition her grasp and lift it to her head in a second movement. During the Study, disabled women with both lower- and upper-body limitations were often observed using superstructure walls in this way, provided the walls were sufficiently low (figure 4.10).

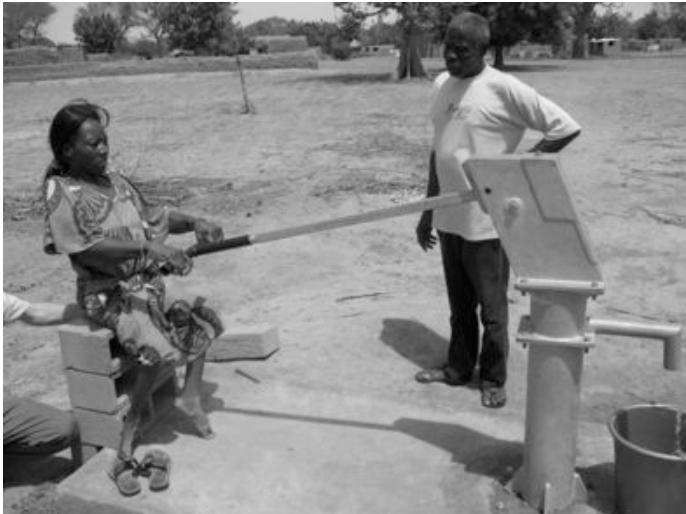
Figure 4.12 A woman with lower-body disability assists with preliminary testing of a T-handle prototype attachment.

For the straight pump handle used with shallow water tables, the Study sought to improve the design so that both able-bodied and disabled users could pump water with greater efficiency and comfort. With input from both formal and informal surveys, and from the time lapse photography, multiple variations of improved handle design were explored and tested. Prototype development and testing involved both short-term trials with both disabled and able-bodied persons, as well as multiple six-month trials with prototypes placed on village pumps (figures 4.12 and 4.13). From this work, two simple models are proposed by the Study.

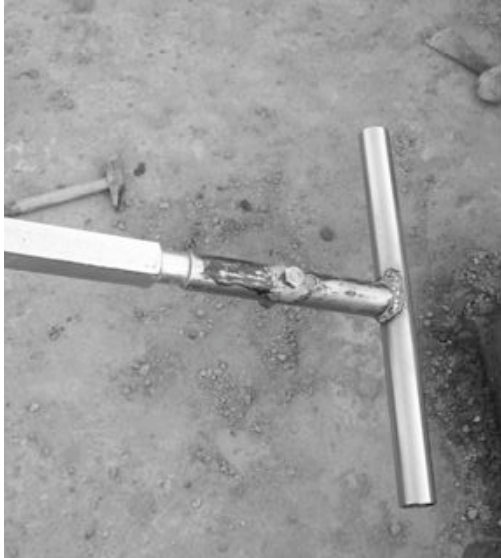
Figure 4.14 *The T-handle accessory can be easily fabricated by local metalworkers and is attached to the pump handle with a single bolt. (Note: Use of two, superimposed nuts can serve to reduce the risk of nuts working loose with pump handle use.)*

hand on the end of the T-portion. In both cases, this grip creates a torque around the handle pivot bearing that is not present when the pump is not used with the handle accessory. *It should be remembered that in some cases such attachments could increase wear on the bearing, although the extent of this potential wear is unknown.*¹⁴ *However, this torque is the same that occurs with the use of the standard Mark II weighted T-handle used on deeper wells.*

Ease and reliability of fabrication by local metalworkers was also tested during the course of the Study. Diagrams and specifications for these handle attachments are found in Appendices 2 and 3.

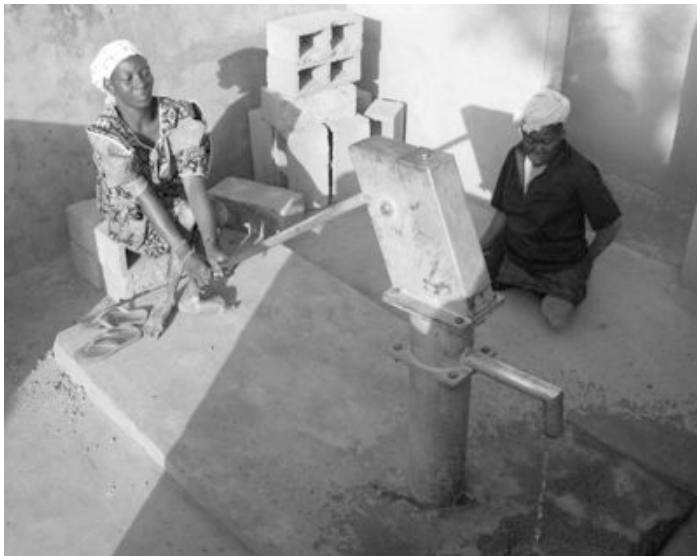
Figure 4.15 Disabled women from the local community assist in preliminary tests of end-seat positioning and height.

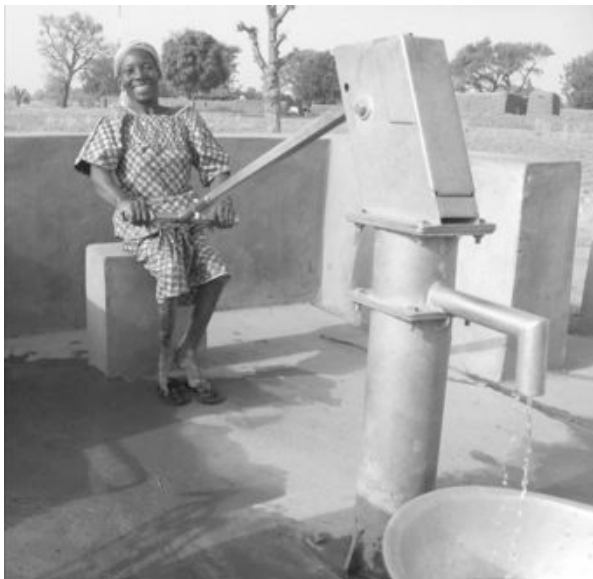
Figure 4.17 A woman with lower-body disability uses the completed combination of the end-seat and T-handle attachment.

impede normal standing positions behind the T-handle for larger able-bodied adults. Yet, there is no evidence that its presence increases pumping fatigue of able-bodied adults. For a disabled person having little or no use of their legs, mounting a 45 cm seat can be challenging if there is not some form of adjacent support. For this reason, it is recommended that the rear enclosure wall be positioned no greater than 35 cm from the rear of the seat. This distance allows sufficient room for

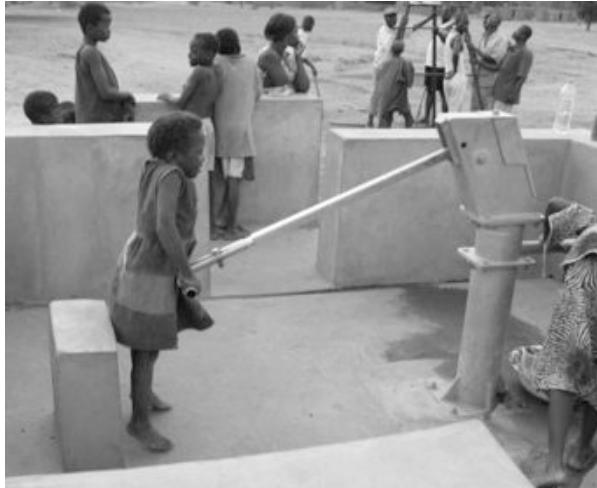
Figure 4.18 A village girl demonstrates use of the T-handle while standing in front of the end-seat.

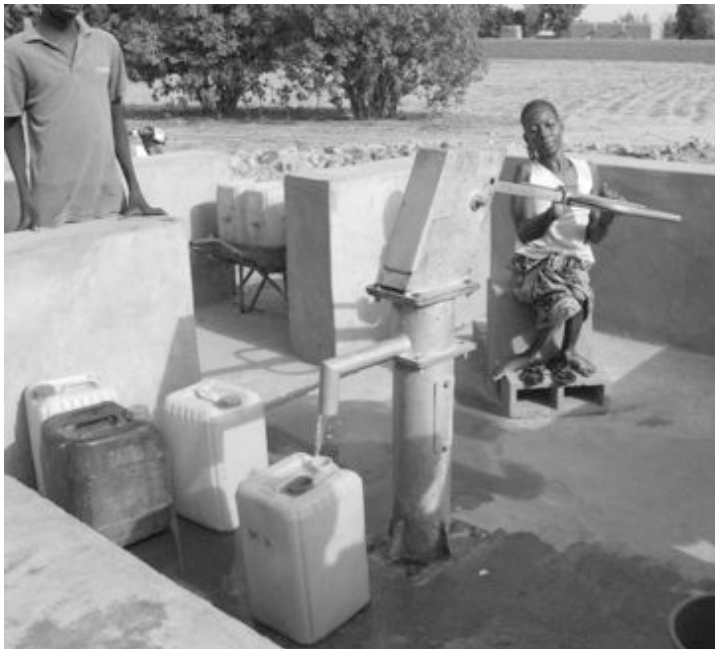
Figure 4.19 A disabled woman assists with preliminary testing of side-seat positioning.

In this position, the “side-seat” is adjacent to the corner of the protective enclosure walls, and therefore out of reach for those who need leverage while mounting the seat. Furthermore, it was found that the angle at which the rectangle-handle is grasped from this seat does not provide as much stability while pumping as the T-handle. As a result, a short step at the

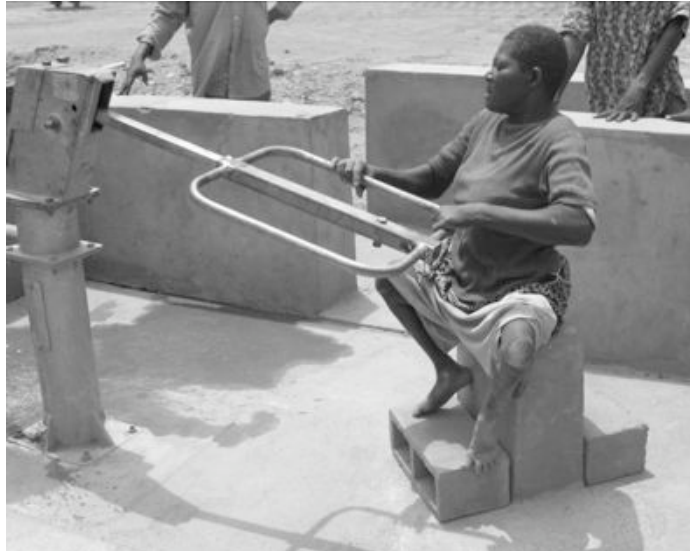
Figure 4.20 A disabled woman, with lower-body disability and limited use of one arm, assists in testing the positioning of a side-seat with a rectangular-handle attachment.

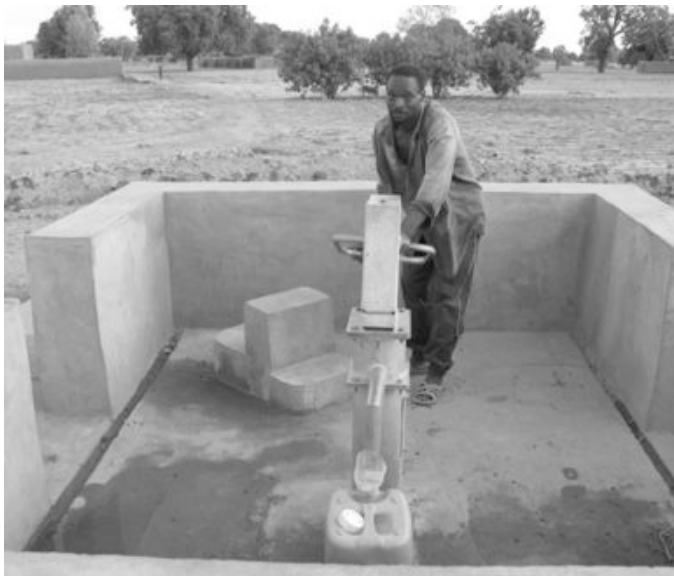
Figure 4.22 An able-bodied man demonstrates use of the pump equipped with the completed side-seat and rectangle-handle attachment. The side-seat is positioned at about 45° from the pump handle, with a high approach step in the rear and a lower leg/foot stabilizer in the front.

If rear or side seats are to be installed, it is recommended that they be constructed of re-enforced concrete and embedded in the floor of the enclosure, so as to assure longevity. Diagrams and specifications are provided in Appendix 1 for both the end-seat and side-seat.

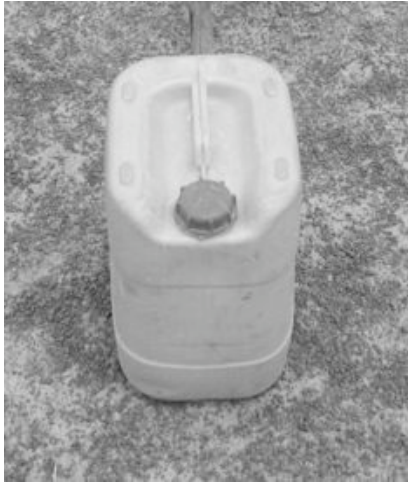
Figure 5.3 Typical jerry can (“bidon”) used for water transport. These have a small screw-on cap, a single top-end handle, and straight sides. Large volumes (20-25 liters) can be carried with these durable jerry cans, but their straight sides, lack of side handles and weight when full can make them difficult to handle.

precluding spillage. Many disabled persons indicate they would prefer to use the large jerry can, but the challenges are that these cans require more precise placement under the pump outlet for filling (often requiring a funnel). The jerry can is more difficult to either lift to the head or carry by hand because of the small handle at the top end and the straight sides. When full, these can be very heavy, and after filling the sides are often wet which can make grasping even more difficult (figure 5.3).

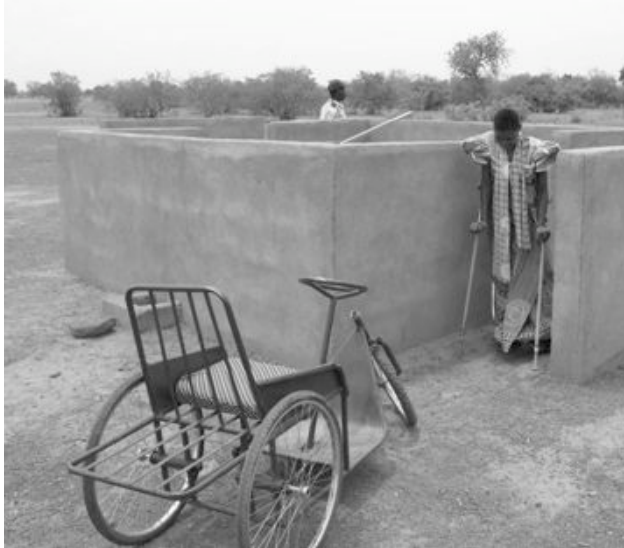
Figure 5.6 Many tricycles for the disabled are built with carrying racks behind the seat; but their height and position behind the seat can make lifting difficult and transport unstable for full water containers.

Tricycles can be used to transport water, but most are not well designed for this purpose, even when they are equipped with a carrying rack behind the seat. The rack is often too high for many disabled persons to reach with a full container. Furthermore, once the container is placed on this rack, the container can be very unstable during transport due to the rack's high center of gravity (figure 5.6). Most persons using tricycles for water transport place the water container on the platform at their feet if there is room, as the center of gravity is lower and the container is considerably more stable during transport. Unfortunately, most tricycles do not have foot-platforms designed with sufficient space for easy carriage of a water container.

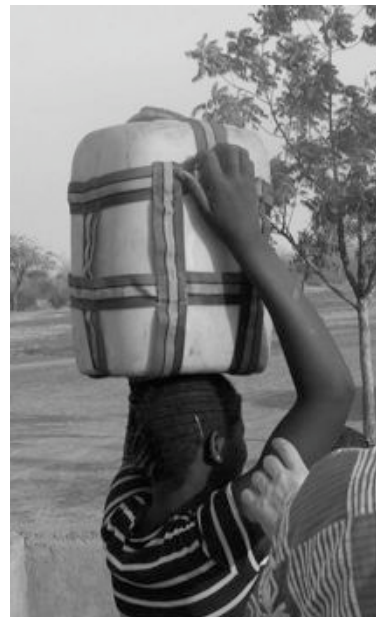
Figure 5.12 Testing of a jerry can holder (“porte-bidon”) made from nylon webbing sewn around the container to facilitate grasping and manipulation.

Among water containers that are locally available, the plastic jerry can is the most robust container that prevents loss of water from spillage. But it can be heavy and difficult to grasp and carry. During the Study, methods to enhance grasping and lifting of these jerry cans were explored and tested. Various types of rope or nylon webbing holders (or “porte-bidons”) were developed and tested. While rope holders can help, they must be made of a water resistant material to avoid deterioration. Tying and knotting must be done well to assure a consistently firm fit on the jerry can. Heating and partial melting of the knots can help assure their hold over time. Nylon webbing can be used to make tighter, more secure holder (figure 5.12). Rope and webbing are available in most markets, and local metalworkers or artisans can assist with sewing the webbing. These holders can be usually be made for about 100-300 cfa, depending on the quality of the material. It should be noted that these do not provide a “rigid” grasp, yet grasping (and therefore lifting and pouring) is improved with these holders. They may need frequent tightening and repair. Furthermore, the nylon begins to degrade from sunlight exposure within a year or so, requiring replacement.

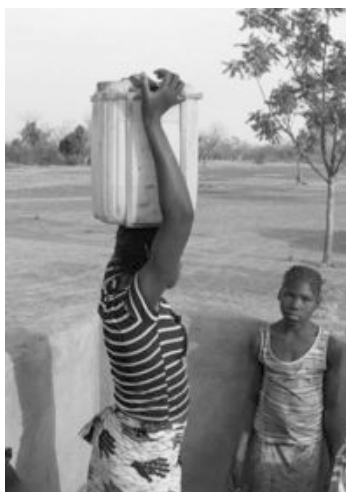
Figure 5.13 *Testing an early prototype of a metal jerry can holder (“porte-bidon”). While functional, this holder’s handles were placed too high along the sides, making it difficult for users with short arms.*

In the effort to provide for plastic jerry cans a more rigid grasp of greater durability, various types of metal holders (or “porte-bidons”) equipped with handles were also developed and tested (figure 5.13). These do not need to be fabricated with heavy gauge material. Light gauge metal, such as small (1-2 cm) flat iron can be used effectively if fitted and welded properly. Handle attachments should

be placed on opposite sides of the container at about 60-70% of the total height. Care should be given to avoiding overly thin or sharp-edged material for the handles, to prevent pain when grasping and lifting full containers. These metal handles can be wrapped in a cloth material to reduce painful grasping. Locally available, jerry cans come in a variety of sizes, and care should be taken to obtain careful measurements when fabricating the holder. In general, it is best to measure the exterior dimension of the jerry can *when it is full of water*, as some expansion occurs. Jerry cans should fit firmly within the holder when full but be easily removable when the container is empty. The bottom of these metal holders should allow for sufficient space for the plastic underside of the container to rest directly on the head of the carrier. A metal band running across the center of this space can be painful to the head when one is carrying a full container. These holders can be fabricated by local metalworkers for about 1,000-2,500 cfa, depending on the quality of material. This represents a considerable expense for many local persons, but a well-built holder should outlast the life of the container by several years. Furthermore, the holder can serve to prolong the life of the jerry can if used properly (figure 5.14).

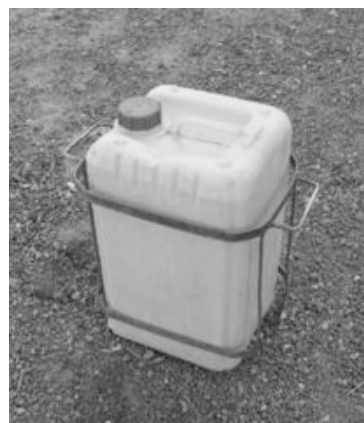
Figure 5.14 *One of the final prototypes of jerry can holders (“porte-bidon”) developed during the Study. Note the minimal amount of metal used and the handles placed on the narrower sides of the container for greater ease of lifting on and off the head.*

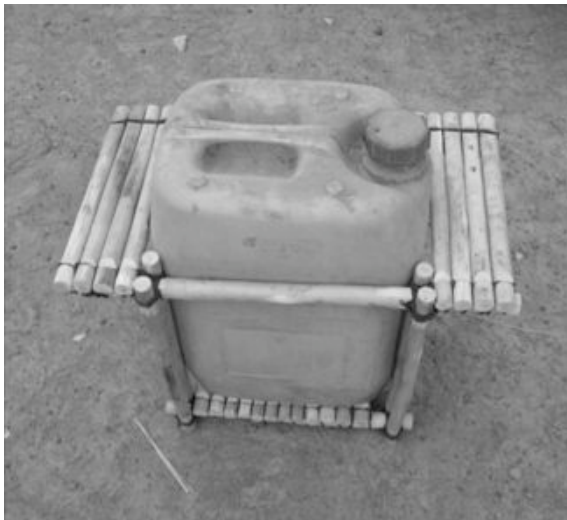
Figure 5.15 A wooden prototype of jerry can holder (“porte-bidon”). These are considerably less costly than metal holders but are not as robust. This prototype is equipped with side handles almost twice the necessary width.

A lower-cost option for rigid holders for jerry cans was explored using the same material and fabrication process as is used in the fabrication of local wooden furniture. The Tominian area of Mali is known for its production of traditionally made chairs, benches and tables by artisans using local wood and a steaming process for treating and bending the wood. Variations of this practice are found in other regions throughout West Africa. Rawhide is soaked and then used to attach wooden parts. As it dries, the rawhide shrinks, providing very firm and rigid attachments. However, the rawhide is susceptible to water, so thin gauge wire (also available in most regional markets in West Africa) was effectively substituted for the rawhide. These wooden holders provide perhaps the easiest and most comfortable grasp for disabled persons, and their cost is about 300-500 cfa. The life of these holders is considerably less than the metal holders, but the wire attachments are all that require occasional maintenance (figure 5.15).

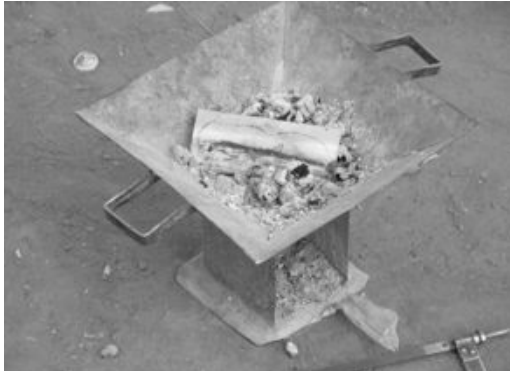
Figure 5.16 Heating the thin flat strip of metal (e.g. aluminum) which will be placed briefly between the container and the handle to be attached. This step will heat both sides for welding.

The metal is easily heated on a bed of charcoal (figure 5.16). However, producing the required high pressure on both sides of the surfaces to be welded requires an adequate tool, as such pressure can generally not be produced manually. For the purposes of welding handles to plastic jerry cans, a simple pressure clamp was developed which can easily be replicated by local metalworkers (figure 5.17). A portion of this clamp is inserted through the opening to provide pressure from the inside of the container, and another portion of the clamp provides pressure from the outside on the piece to be welded to the container (figures 5.18, 5.19, and 5.20). The design specifications for this clamp are provided in Appendix 4. For this method to work properly, both the container and the handle must be HDPE plastic. Once handles are welded to both sides of the container, all sharp edges should be rounded with sand paper to avoid painful grasping (figures 5.21 and 5.22).

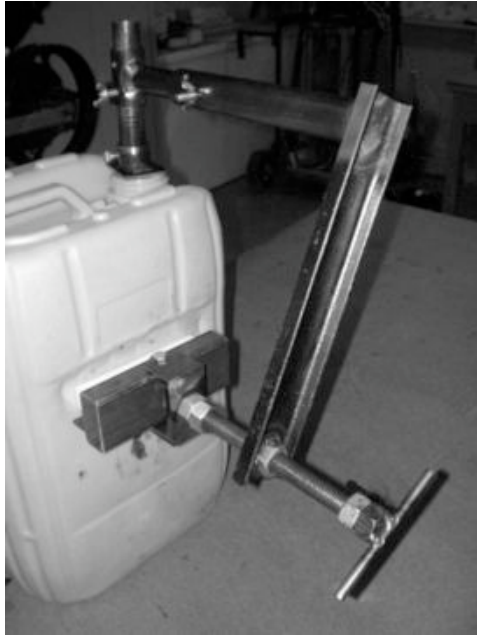
Figure 5.18 Once the heated metal plate has been inserted briefly between the container and the handle (white piece), the pressure screw is ready for immediate tightening.

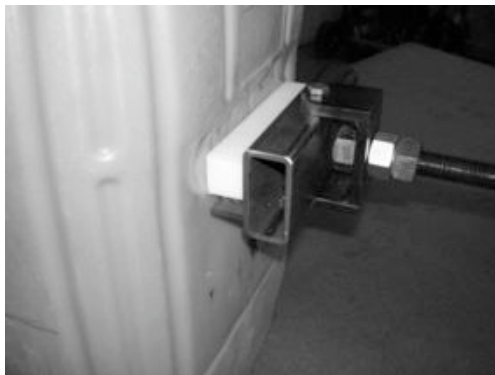
Figure 5.19 A close-up view of the external pressure plate on the handle (white piece) to be welded to the container.

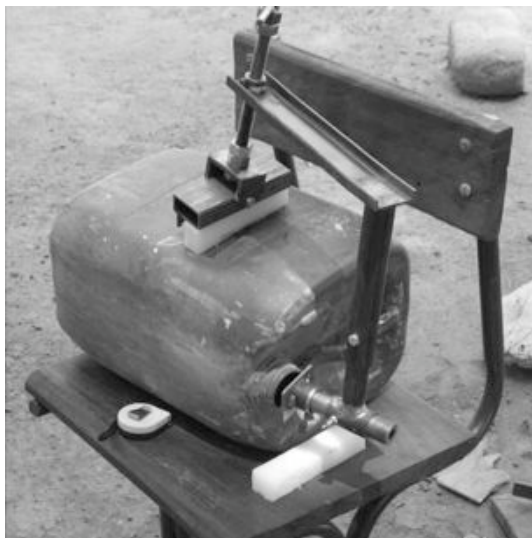
Figure 5.20 The pressure clamp is used by a local metalworker to weld handles to jerry cans for distribution and testing among disabled persons in the target communities.

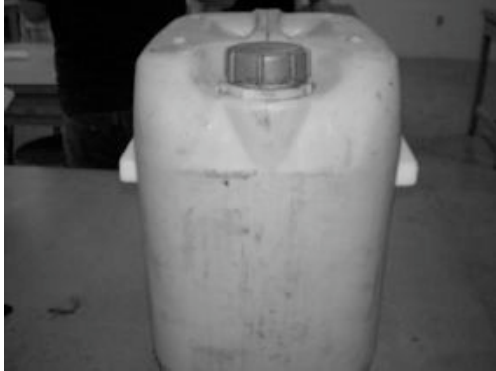
Figure 5.21 A view of the completed handle welding process on a jerry can.

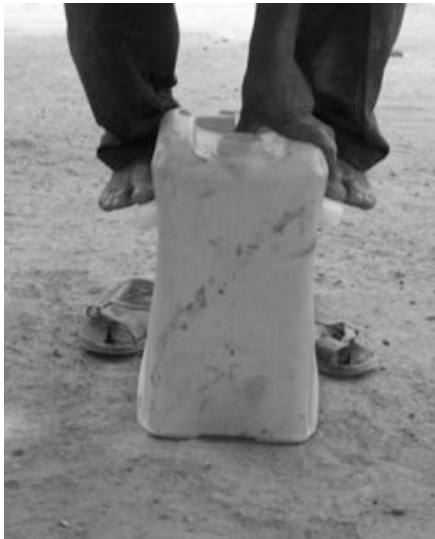
Figure 5.22 A local metalworker demonstrates the strength of the completed weld between the handle and jerry can.

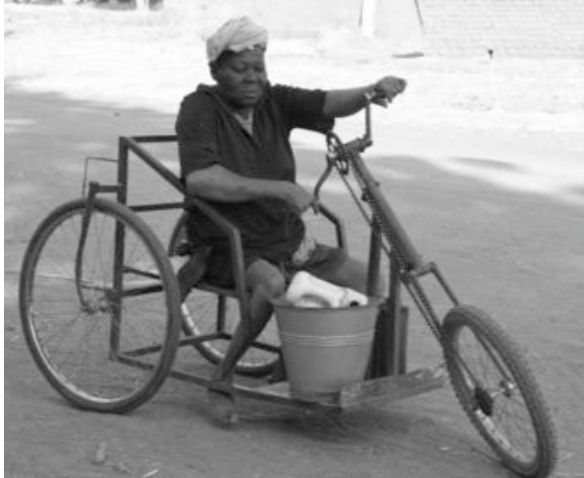
Figure 5.23 A disabled woman uses the foot platform of her tricycle to transport water, as the low center of gravity enhances container stability and reduces splashing, but the placement of the container leaves little room for her legs. Notice how the support frame intersects the center of the foot platform, limiting space for carrying objects.

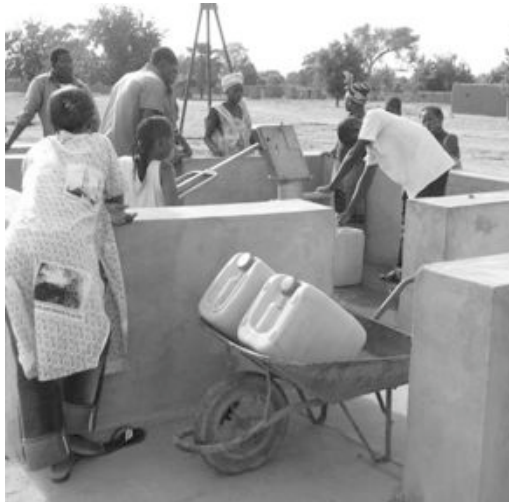
Figure 5.25 Wheelbarrows can be used to facilitate the transport of heavy water containers, but they also require strength and coordination that may be beyond the capacity of many disabled persons.

If disabled persons have access to animals of burden (e.g., donkeys), animal-pulled carts, wheelbarrows, etc., these can be used to facilitate transport (figure 5.25). But most cannot afford these items and many are unable to use them due to their physical limitations. From region to region, different means of innovative transport can be found. Disabled men or older children may use donkeys or even bicycles to assist in transporting water (figure 5.26). With bicycles, containers can be attached by a short cord draped over the bicycle which is then pushed to the place of residence (figure 5.27). If the disability is not too severe, a shoulder cross bar can be used to facilitate the transport water (figure 5.28). Many other such examples can be found across the West Africa region. However, in addition to posing new and unique physical challenges, many of transport methods, when applied in regions or cultural contexts where they are foreign, may conflict with local norms and expectations, creating new social challenges for the disabled.

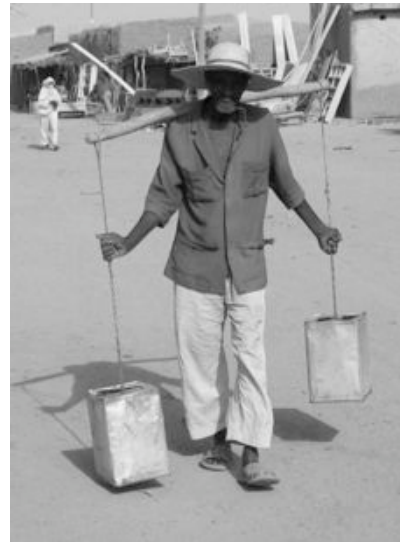
Figure 5.28 In some parts of West Africa, dual containers are transported using a shoulder yoke. This method can enhance water transport for some disabled persons; especially those with upper body limitations (in their arms or hands).

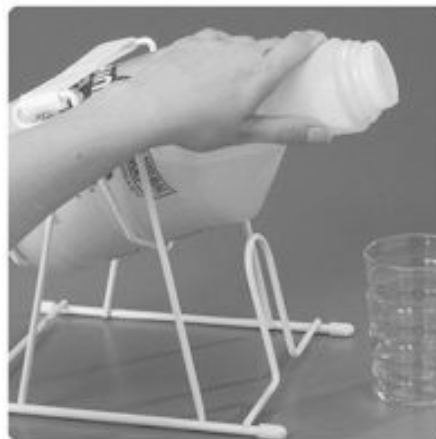
Figure 5.29 A small tipper used to pour liquids into a drinking glass. This simple device was developed for persons with unsteady or weak grasping ability.

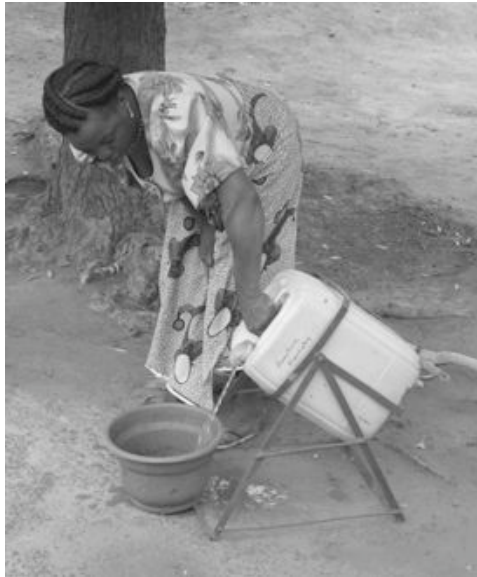
Figure 5.30 A disabled woman tests an early jerry can tipper prototype. Note the overly wide base of the support frame, which impedes good placement of the receiving container directly under the jerry can outlet. The tipper also lacks a handle at the base of the holder, requiring awkward handling from the top of the jerry can.

cans with the assistance of local metalworkers and with input from disabled women in the community (figures 5.30, 5.31 and 5.32).
