Water, Sanitation and Disability in Rural West Africa

**Enhancing Access and Use of
WASH Facilities**

**A Summary Report of the Mali Water and Disabilities Study
March 2010**

Prepared by
W. Ray Norman, Ph.D.
Dean, School of Mathematics, Engineering and Business
Messiah College

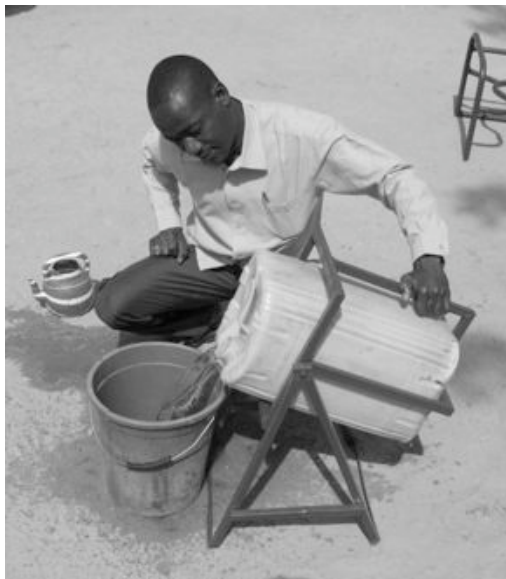
Figure 5.31 Jerry can tipper prototype fabricated in Niger with square, light gauge, iron tubing.

cans with the assistance of local metalworkers and with input from disabled women in the community (figures 5.30, 5.31 and 5.32).

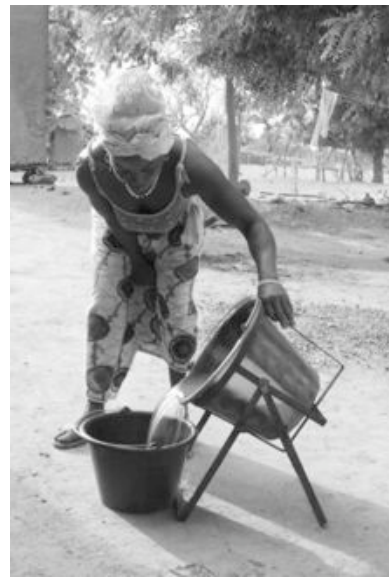
Figure 5.32 Metal bucket tipper being used by a woman having the use of only one arm.

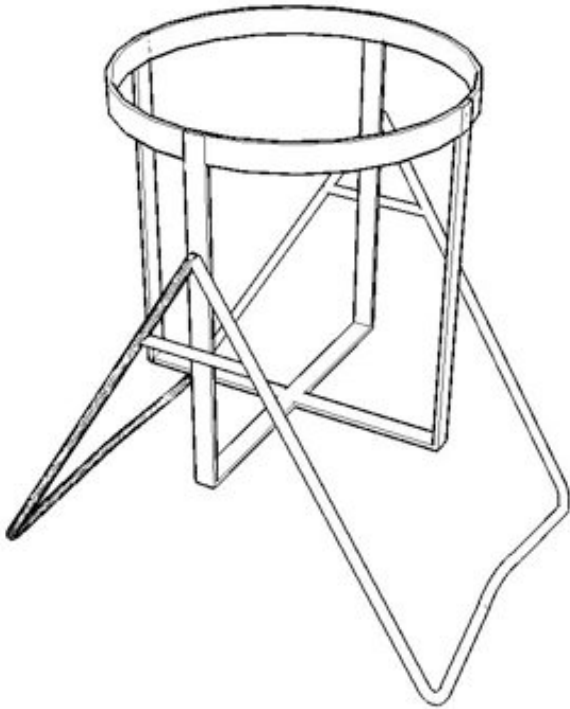
Figure 5.33 Basic design for the metal bucket tipper, including the circular bucket “holder” and the supporting “A” frame base. The holder and A-frame support are joined on either side at a single pivot point.

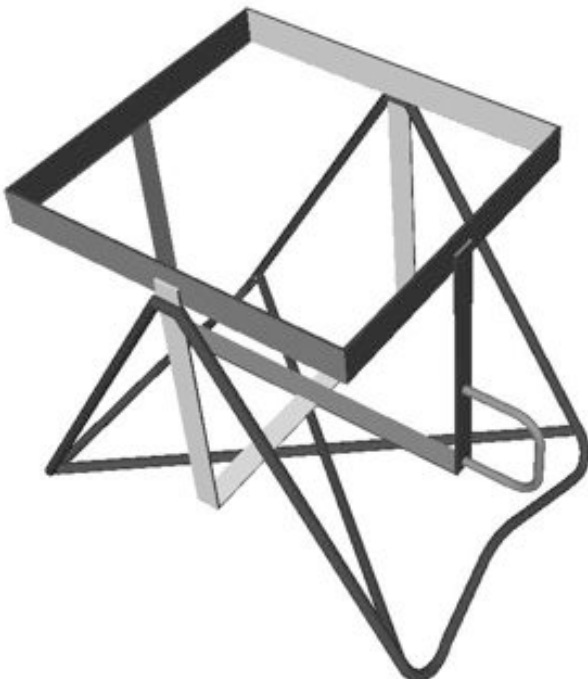
Figure 5.34 Basic design for the metal jerry can tipper, including the rectangular bucket “holder” and the supporting “A” frame base. The holder and A-frame support are joined on either side at a single pivot point.

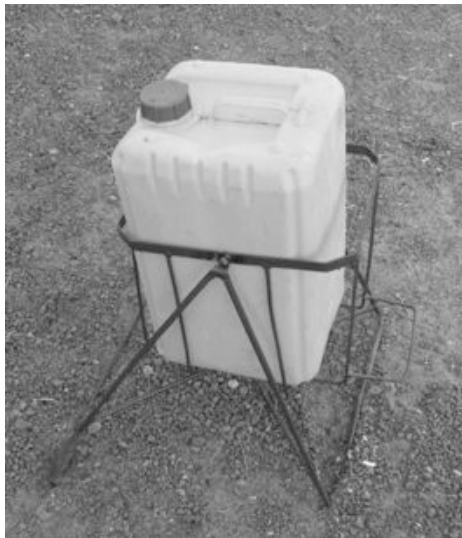
Figure 5.35 Final version of a jerry can tipper.

Figures 5.35 and 5.36 depict final versions of the jerry can tipper. If properly used, the metal tipper should last for several years. Only the pivot bolt may need replacement from time to time, depending on the frequency of tipper use. Metal tippers are durable and stable and can be manufactured by local metalworkers for about 2,500 cfa or less.

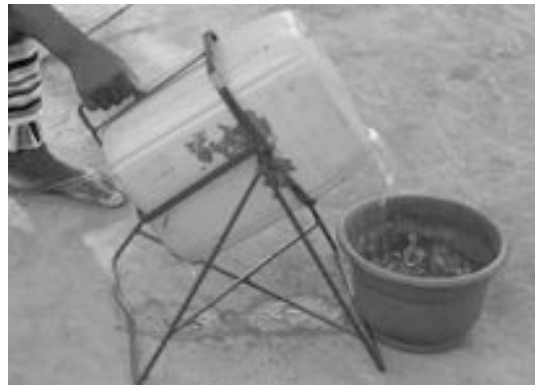
Figure 5.36 Final version of a jerry can tipper being demonstrated.

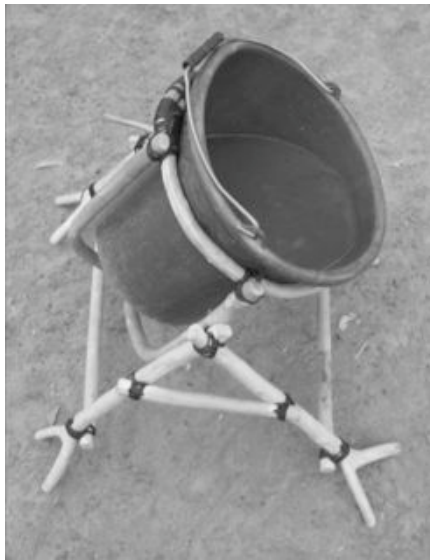
Figure 5.37 An early prototype of the wooden bucket tipper, made by local artisans in the Tominian region of Mali.

A wooden version of the container tipper made by local artisans was also developed for the bucket and jerry can. These can be fabricated for a third or less of the cost of the metal tippers (about 500-1000 cfa). Local, steam-treated wood is used and constructed with locally available wire. (The typically used rawhide does not hold well when wet.)

Prototypes are depicted in figures 5.37, 5.38 and 5.39. These tippers can be made using basically the same principles and dimensions as those for metal tippers (the 7 guideline steps detailed above). It should be noted that aside from the pivot point, no bolts, nails or screws are used in fabrication. Due to its weight-bearing use and daily manipulation, along with the presence of water, the use of these metal items are not advised. Over time, wired joints tend to maintain a more durable structure than do more common carpentry items such as nails and screws.

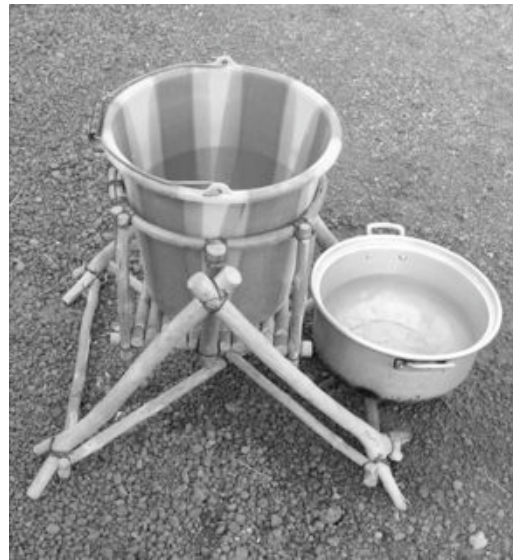
Figure 5.38 One of the final prototypes of the wooden bucket tipper, using local wood attached with thin metal wire.

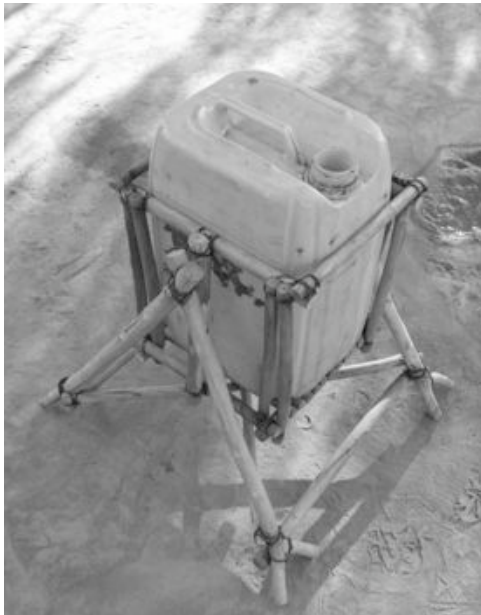
Figure 5.39 *A final prototype of the wooden jerry can tipper.*

The two primary challenges with this type of construction are: a) the proper placement of the pivot point on the holder; and b) the wear and tear, which occurs on the pivot point during use. When locating the pivot point on the bucket or jerry can holder (step 3 above), the center of gravity (or mass) must be considered in addition to the dimensions. Since these are of handmade construction, the weight distribution of the holder may not be symmetrical with respect to the holder's dimensions. Even if the right dimensions are used, the completed tipper can be off-weight (and therefore suspend unevenly) due to variations of weight distribution resulting from the

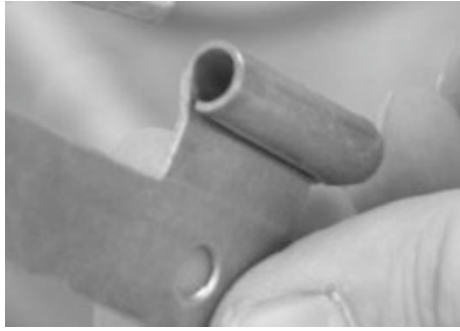
Figure 5.40 The sheath portion of a discarded metal hinge can be removed, inserted into the wooden support frame of a tipper, and serve as a protective sheath for the pivot bolt; thus reducing wear and tear on wooden parts.

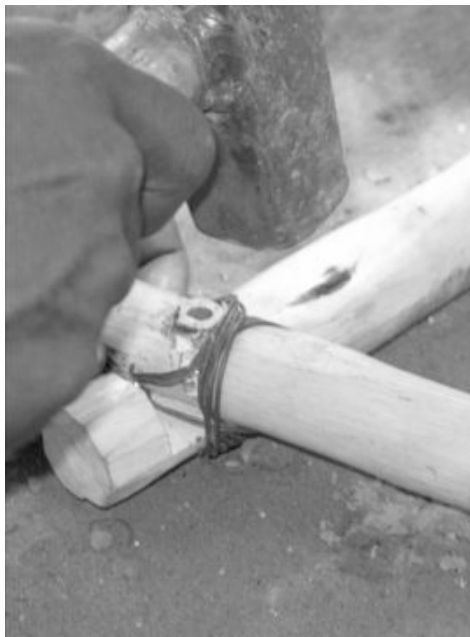
Figure 5.41 Circular hinge housing or sheath being inserted into the support frame of the tipper.

Once the flat portion has been removed using a metal saw, the circular hinge housing can be firmly inserted into a small hole drilled in the support frame (figure 5.41). This will serve as a protective sheath for the bolt and should fit very firmly in the drilled hole so as to avoid movement against the wood. A bolt can then be fixed to the holder and inserted in the support frame housing to facilitate free pivoting without creating wear on any wooden parts. The bolt should be of sufficiently small diameter so as to rotate freely within the metal sheath. If properly placed, the pivot (both bolt and housing) should only need replacing once or twice each year, depending on the frequency of use.

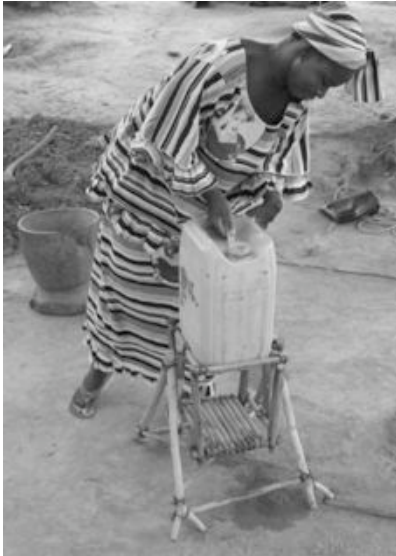
Figure 5.42 It is important before fabricating tippers to take measurements from containers when they are full (and thus expanded). This will assure easy placement and removal of the container in the completed tipper.

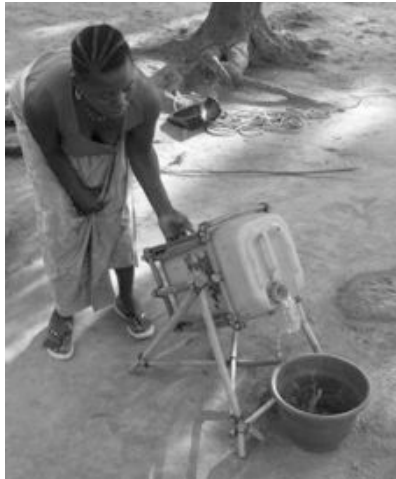
Figure 5.43 Woman with limited upper-body mobility uses a wooden jerry can tipper in the home.

As with metal tippers, it is also important to take measurements of the water container when it is full, before fabrication of the tipper, so as to assure easy placement and removal of the container from the tipper (figure 5.42). Furthermore, since these are fabricated with wood and wire, it is important that sufficient bracing is firmly built into the support frame to reduce wobble and enhance stability of the tipper when it is in use. (Note the “X” cross bracing at the base of the support frame in figures 5.43 and 5.44.)

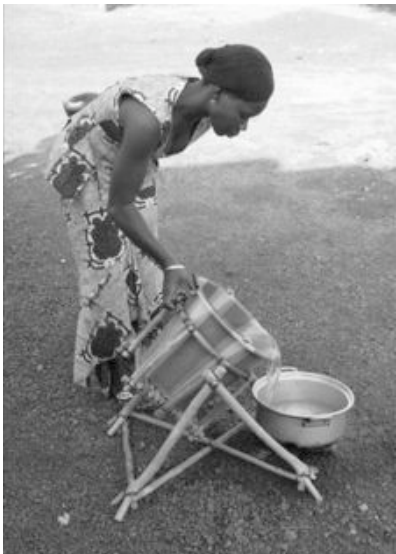
Figure 5.44 Young woman demonstrates the use of a wooden bucket tipper.

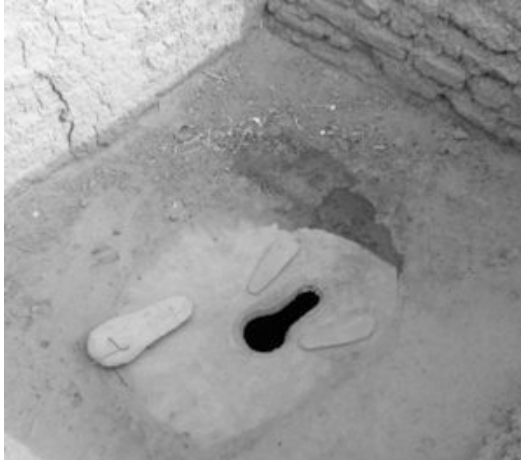
Figure 6.3 A sanplat latrine soiled by urine from improper use and poor drainage.

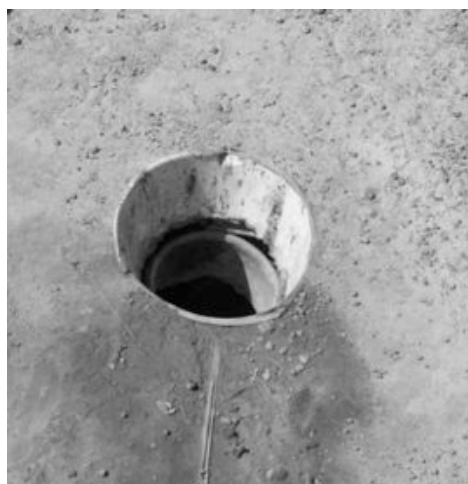
Figure 6.5 A traditional latrine used by a disabled person who, due to lack of adequate leg strength, must sit directly on the hole. Note the rim of the hole (the remains of an old metal container) is flush with the ground surface so as to minimize discomfort when the user is seated on the ground.

and raising themselves when they visit the latrine. Many more mentioned having to sit directly on the latrine seat (or hole, in some cases) due to an inability to maintain a squatting position. This is not only painful for most, but given the soiled nature of many household latrines, extremely unhygienic (figures 6.5 and 6.6). Furthermore, these same individuals must struggle to sufficiently raise themselves so as to adequately clean themselves following defecation. This is often done by leaning to the left or right to gain adequate clearance between the buttocks and latrine hole.

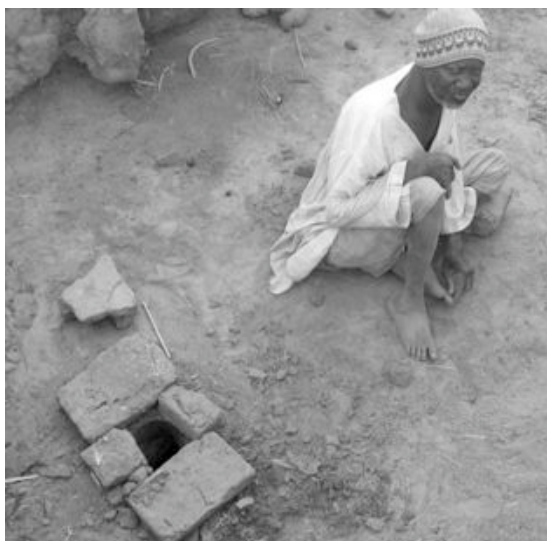
Figure 6.6 This disabled man, with limited use of his legs, must crawl on all fours to visit his traditional household latrine. Here he demonstrates how he temporarily places dried mud bricks around the latrine hole to better place himself for latrine use without becoming soiled.

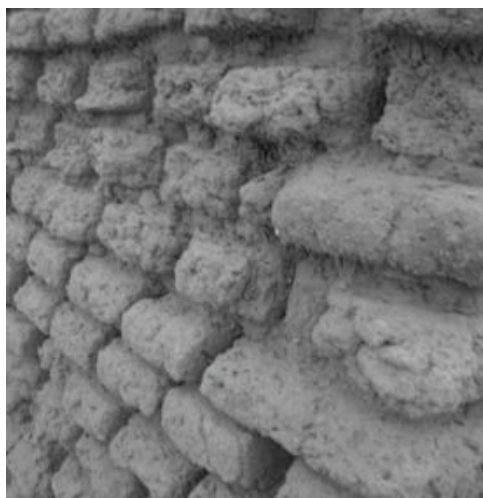
Figure 6.8 Exposed clay brick walls in the interior of latrines, while subject to deterioration by seasonal rains, can provide helpful handholds and support for some disabled and elderly persons.

Many disabled persons can be assisted with handhold accessories attached to or embedded in latrine walls. While handhold accessories can be placed in clay brick walls, there are several challenges in doing this. Dried, clay brick construction is not strong, so any hand accessories should be embedded and pass through the entire thickness of the wall, so as to insure that they do not pull out when used. Accessories made from wood generally do not last long as they are subject to termite infestation (unless the wood is well treated, which can be costly). Metal handhold accessories have a considerably longer life but can be expensive for local consumers. It was noted that some disabled and elderly persons will use exposed brick in the interior walls of the latrine for support. This situation is usually found where the brick wall has not been fully plastered after construction (figure 6.8). This leaves the brick edges exposed for hand use support (but in some cases it also leaves the wall more susceptible to erosion from seasonal rains. When available, dried laterite brick is much more resistant to deterioration and provides a much sturdier wall

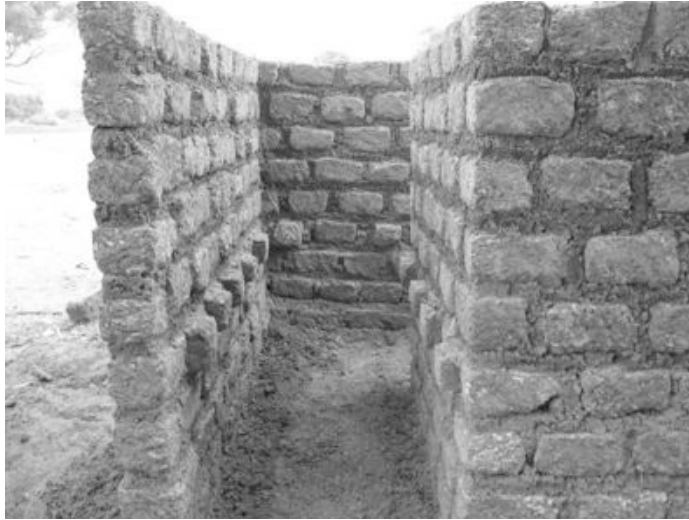
Figure 6.10 The entranceway of a latrine made from laterite brick and clay mortar. Note the protruding bricks (placed sideways) which provide handhold support for latrine users.

are needed. Bricks can be turned outwards to provide handhold support for both entering the structure and for squatting. (A diagram of the Study prototype can be seen in figure 6.9, and a photo of the entranceway of a low-cost prototype with these handholds and constructed with laterite brick and clay mortar can be seen in figure 6.10.) Protruding bricks should be placed at hand level on both walls of the entranceway, and should continue around the main interior wall to the latrine. At the latrine, protruding bricks can be placed at lower levels on either side of the latrine to facilitate squatting.

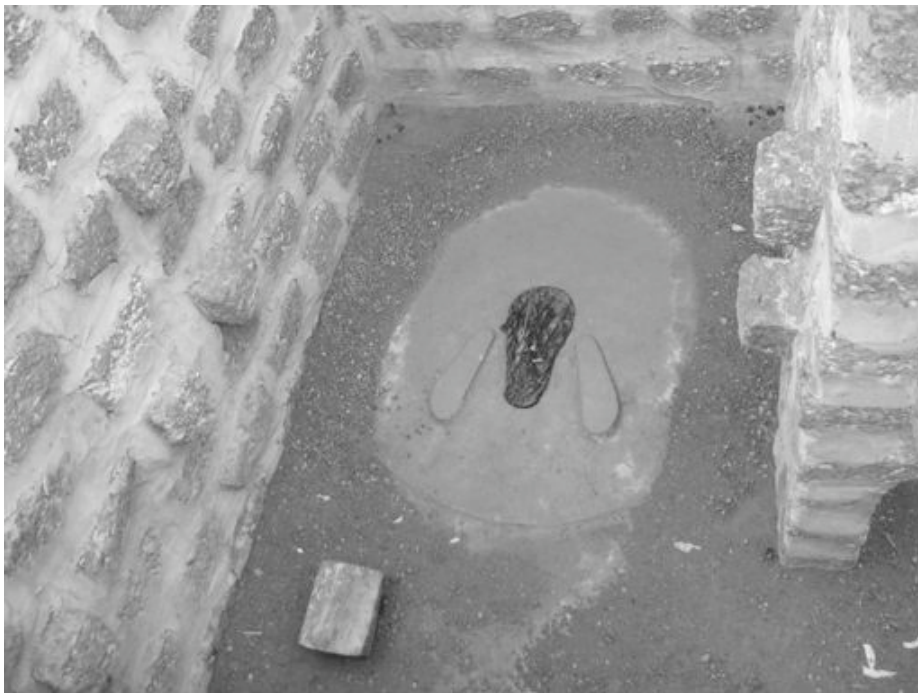
Figure 6.11 A latrine prototype using the design depicted in figure 6.9. Note protruding bricks to facilitate lowering to and rising from a squatting position, with a bathing stool in the foreground. Drainage under the enclosure wall is located just outside the photo on the left wall, just below the bathing stool. (Note that this prototype uses laterite brick and cement mortar. High quality clay can also be used for effective mortar with laterite brick, for considerably lower cost.)

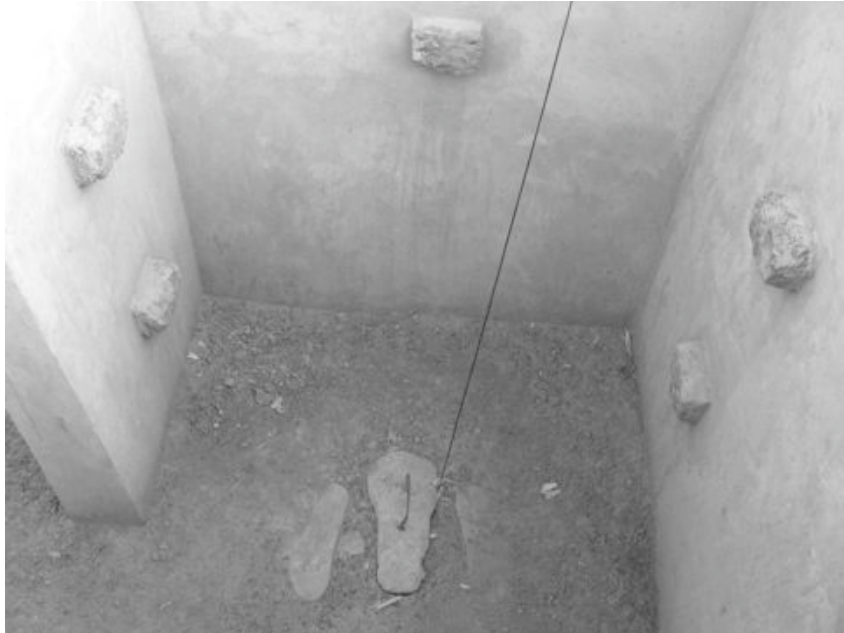
Figure 6.13 A sanplat latrine with cover, equipped with a vertically placed string for assisting the visually impaired in hole location and body positioning when squatting.

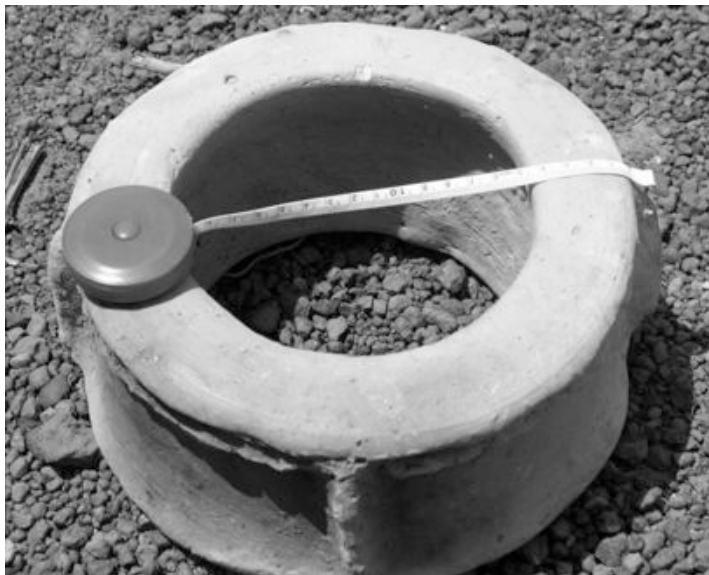
Figure 6.14 Terra cotta (baked earth) latrine seat for traditional latrines; fabricated by a local potter.

In the effort to provide a low-cost solution for disabled persons who lack sufficient lower-body strength to squat, the fabrication of fired-clay seats was explored. Many moderate sized villages and towns have skilled, traditional potters who produce terra cotta containers for water transport and storage. The Study worked with a potter in Tominan to develop and test several prototypes for use with both traditional latrines and the sanplat (figures 6.14 and 6.15). Some practice is required to shape seats that can support the

weight of a person yet have sufficiently thin walls to assure proper firing. These seats can be produced for about 400-1,500 cfa each. While disabled individuals had varying preferences for seat height, the recommended standard height for these is 15-20 cm.

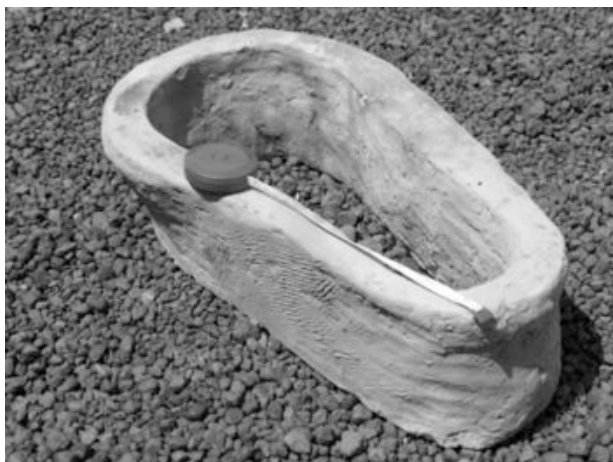
Figure 6.15 Terra cotta (baked earth) latrine seat for sanplat latrines; fabricated by a local potter.

Circular seats for traditional latrines should have a diameter of about 25 cm, but this can vary depending on the size and shape of the traditional latrine. Terra cotta seats for the sanplat should be fabricated by simply following the dimensions of the latrine opening. The top rim should also have wide and well-rounded edges to provide greater comfort to the user.

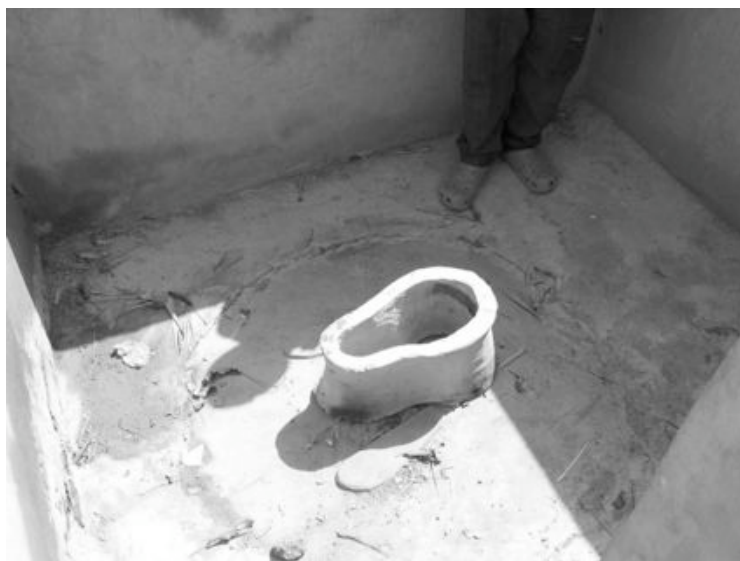
Figure 6.16 Terra cotta latrine seat in use on a sanplat latrine in the home of a polio victim. When not in use, the seat is moved to the side of the enclosure for storage.

There was a largely favorable response from disabled persons assigned these seats for testing over a period of 6 months. In addition to no longer having to sit directly on the latrine hole, the low cost and ease of local fabrication was particularly appealing. Also the seats are very

weather resistant and can be left in the latrines year round (figure 6.16).

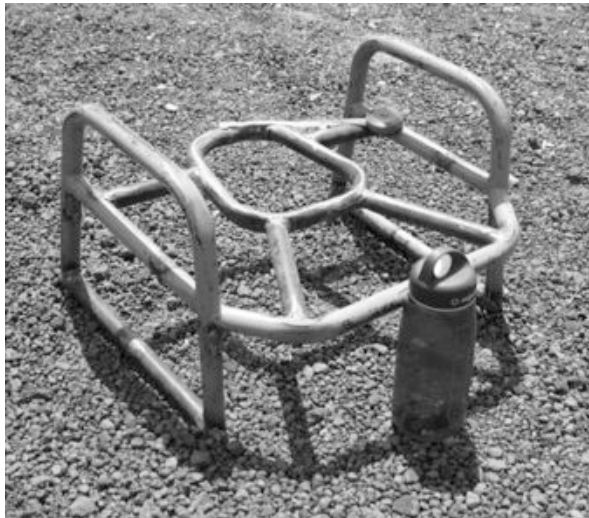
Figure 6.17 An early metal latrine chair prototype developed during the Study. While functional and sturdy, this design with an enclosed seat and adjacent bracing limits hand access for cleaning (either from the front or from the rear).

The Study worked extensively with local metalworkers and disabled volunteers to develop simple, durable devices to assist with squatting, cleaning and mobility. A wide variety of chairs was developed and tested over a period of 18 months, with the assistance of both male and female volunteers from target communities (figures 6.17, 6.18 and 6.19).

open at one end. This opening is necessary to facilitate hand access for cleaning and rinsing after defecation. The seat opening does not need to be larger than the maximum width of the seat. In most cases, it should actually be somewhat smaller, as seen in figures 6.22 and 6.23. Early chair prototypes were built with circular (or enclosed) seating and did not include these openings (figures 6.17 and 6.19). User feedback quickly indicated that this design impeded effective hand access and cleaning, and the future designs were adapted accordingly.

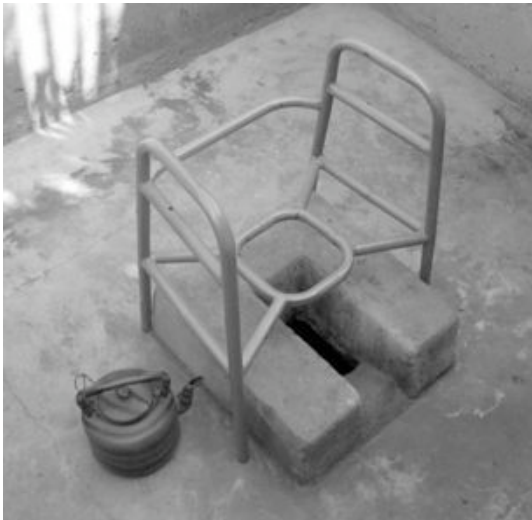
Figure 6.19 This early latrine chair prototype was developed for use by a disabled person needing assistance to walk from her room to the household latrine and to squat while using the latrine. The handles are made at a height which can easily be grasped from an upright, walking position. The handles and other side bracing provide support for lowering and raising herself from the latrine.

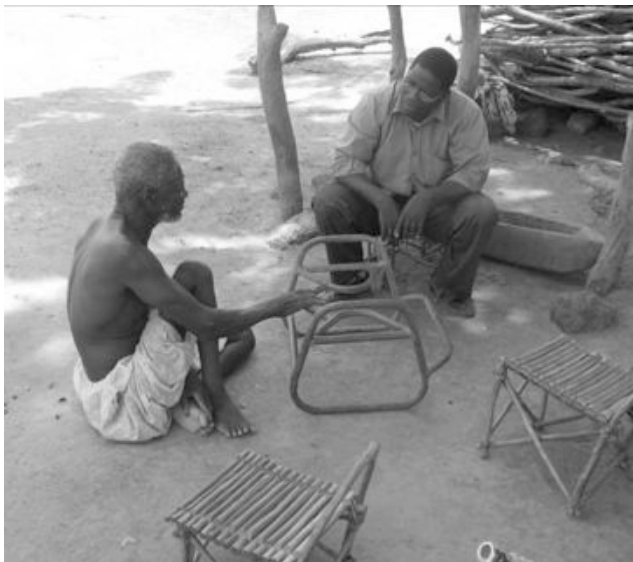
Figure 6.20 A local metalworker and disabled client discuss potential improvements for a latrine chair. Direct and frequent exchanges between fabricators and clients are essential for the effective development of locally made assistive devices.

1. Input from Disabled Persons: It is very important that information is exchanged between disabled persons and artisans when designing and fabricating latrines. Metalworkers and artisans must take the time to listen and understand the constraints and limitations of the disabled client. Information on the type and extent of disability, personal latrine use habits, cleaning practices and personal preferences are all important issues which should be taken into consideration. It is equally important that the disabled persons understand the artisans' limits and constraints in fabricating such seats (figure 6.20).

surface the chair's front legs will likely sink into the soil with the full weight of the user. Low-placed braces between chair legs, as seen in figures 6.23 and figure 6.24, can serve to enhance seat stability and prevent chair legs from sinking in the soil surface. Rounded seat frames (figures 6.20 and 6.23) serve to reduce the cost of welding, but when placed on a hard, flat surface some users find the seat tends to rock backwards. If this design is used, then the base length of the side frame should be sufficiently long so as to prevent that instability.

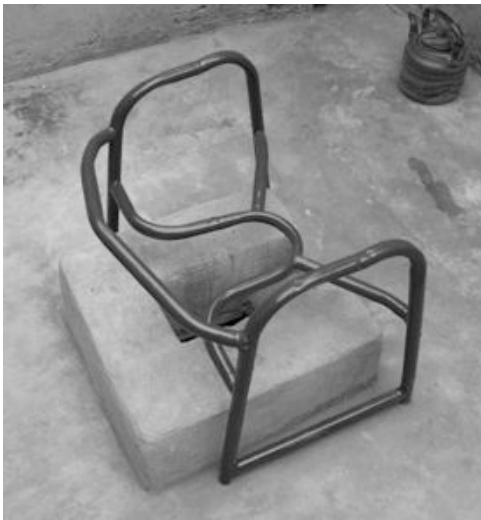
Figure 6.24 Low placed support bracing on the side of this latrine seat makes it more stable and less likely to sink in the ground if used on an earthen surface (such as is found in most traditional latrines).

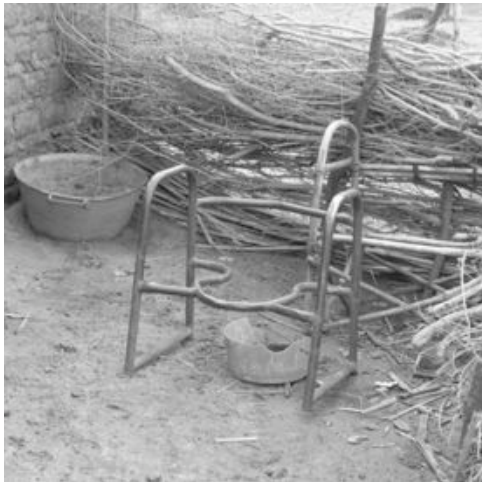
Figure 6.25 For the many disabled persons who do not have a pit latrine in their home, latrine seats can facilitate defecation and enhance personal hygiene in the process. A recent stroke victim uses this chair with a receptacle.

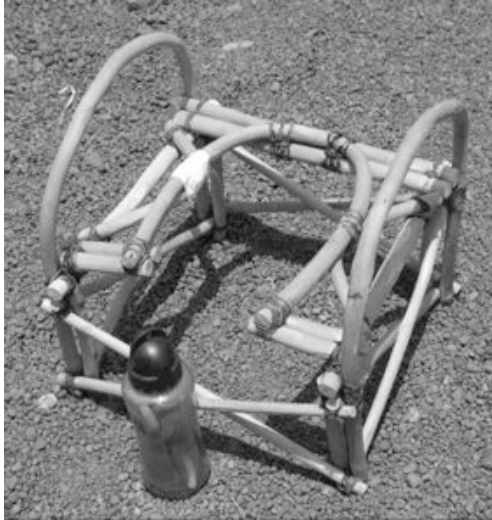
Figure 6.27 Chaise Bagayogo: The standard-sized wooden latrine seat developed by the Study which can be used from either direction, depending on preference for front or rear cleaning. The chair is light, sturdy, locally fabricated and low-cost.

As with metal container tippers, the Study examined lower-cost options for latrine seat design and fabrication. Local wood-working artisans in the Tominian region used metal latrine seat models to develop lower-cost wooden versions. Various models were developed, tested and improved over a two-year period. *The same 8 guidelines listed above also generally apply to the development of the wooden version of the latrine chair.* These can be produced by local artisans for a cost of about 1,000- 2,500 cfa, depending on the size of the chair and the amount of material used. A standard model which can be used by the majority of disabled persons with lower-body limitations was developed and is referred to as the “Chaise Bagayogo” (figure 6.27).²⁴ A diagram and recommended dimensions are provided in figures 6.28 and 6.29. This wood design of the latrine chair has the advantages of being low-cost, lightweight and easily portable, and weather resistant. This particular design is also easily usable for either front or rear cleaning (depending on which way the chair is turned), as there are no cross braces above the seat level.

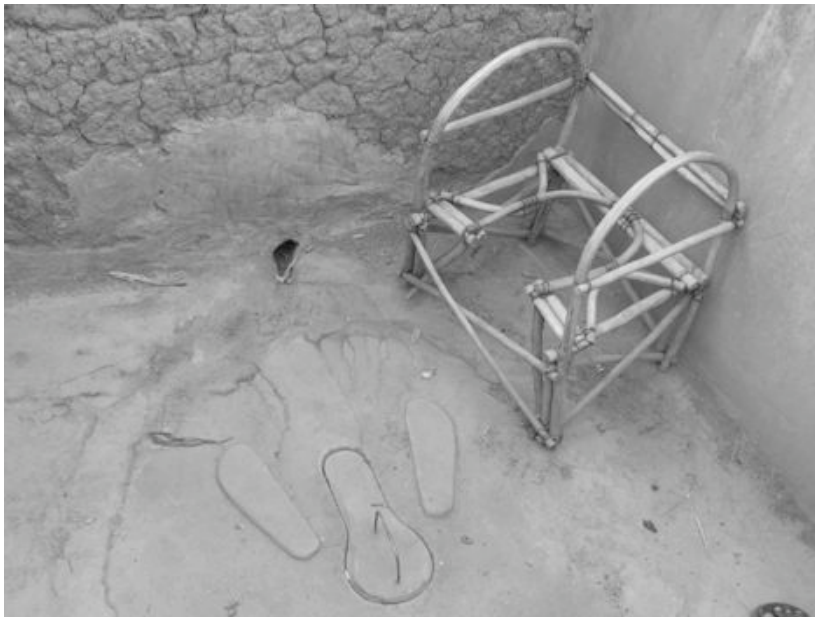
Figure 6.30 *Wooden latrine chairs made with wire binding can be stored in the latrine area for easy access and use.*

Repairs: Repeated use and long-term exposure to rain and sun can reduce the strength of wire binding over time. Tightening or replacement of the wire binding may need to be done every 2-3 years if the chair is typically stored outside in the open latrine area. The wood, however, should last for several years without needing replacement (figure 6.30).

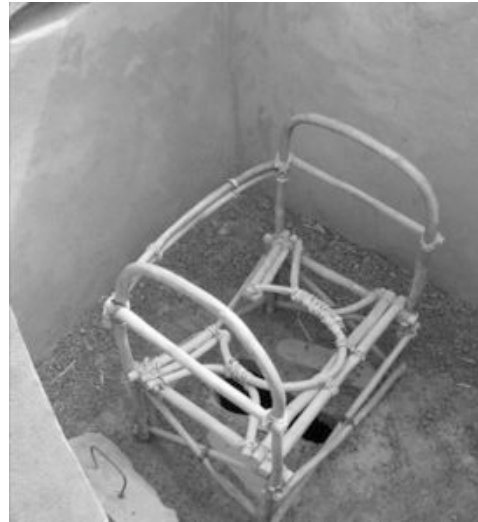
Figure 6.32 *A wooden seat built for rear cleaning positioned over a sanplat latrine. It is also designed with high handles to assist with walking.*

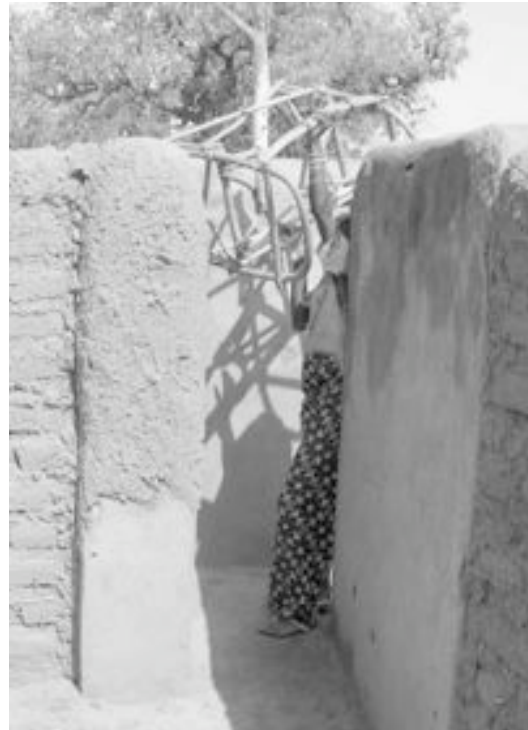
Figure 6.33 *Wooden chairs must be built with the size of the latrine entranceway in mind; or latrine entrance ways need to be constructed to accommodate passage by assistive devices. This latrine chair must be lifted above the latrine entranceway.*

As with metal latrine chairs, wooden chairs can also be fabricated for a variety of conditions and needs, with variations in both seat and handle height being the most common. On occasion, a disabled client may ask for a seat that is higher or one that is larger or smaller than the standard model described in figure 6.28. Some disabled persons also need an assistive device for walking and will request a chair with higher handles (figures 6.31 and 6.32). Whenever chairs are made with larger dimensions, care needs to be given to the entranceway width of the latrine that will be used — as some chairs may be too wide for convenient entrance to the latrine (figure 6.33).

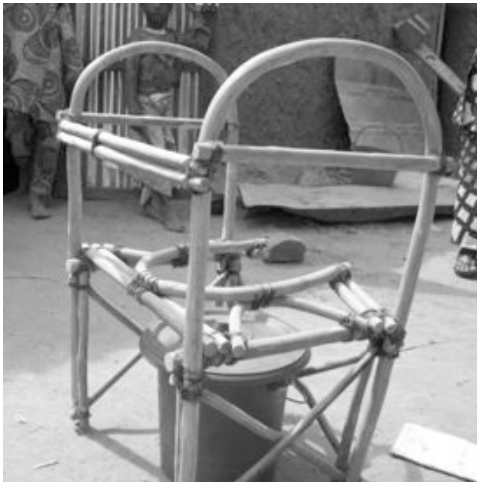
Figure 6.34 Latrine chairs can be built to easily accommodate receptacles for home-bound users. This chair, designed for front cleaning, is equipped with an open back to facilitate placement and removal of the receptacle.

Many disabled persons, and especially the elderly, are unable or unwilling to leave their home or bedchamber to relieve themselves. In such cases they are obliged to use some type of container in which to capture the human waste. Low-cost wooden seats adapted for use with these containers can serve to greatly facilitate this process (as depicted in figure 6.25 with a metal chair). While smaller containers can easily be used with the standard wooden chair model (figure 6.28), some individuals may prefer larger containers and/or higher seats. In such cases, the cross bracing can be left off of the lower back side of the chair to facilitate placement or removal of the container. Figure 6.34 depicts such a seat with an open back side, and figure 6.35 depicts the chair's use in the bedchamber of a disabled, elderly man.

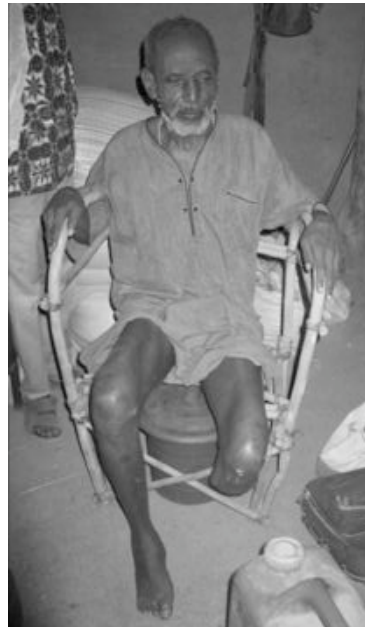
Figure 6.35 Having lost his sight and leg from diabetes, this elderly, homebound man demonstrates the use of his latrine seat within his bedchamber.

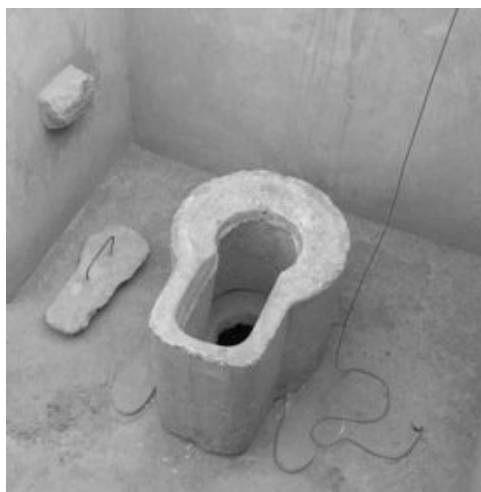
Figure 6.36 A cement latrine seat designed by WaterAid Mali for use by the visually impaired.

Many persons with lower-body limitations may also be visually impaired. Quite frequently, these are elderly people. In such cases these people are in need of a portable latrine chair to assist with squatting, but the challenge of accurate placement of the seat over the latrine can be problematic. In many such cases, these persons must rely on household members' assistance for proper placement of the chair. Otherwise, the individual could use a chair equipped with a sizable container underneath, thus alleviating the need for accuracy in the placement of the chair. WaterAid Mali developed a concrete seat for the blind which can also assist people with these combined disabilities (figures 6.36 and 6.37). This seat can be placed over a sanplat latrine and can be easily located and used by the visually impaired. The seat of about 30-35 cm height is also easily used by those with lower-body limitations. This type of seat is ideally used in cases where the disabled individual is the sole user of the latrine. Since the seat is intended to be placed permanently over the sanplat, other users of the latrine are also compelled to use the seat – requiring major changes of habit by the able-bodied and the risk of having the seat soiled by less enthusiastic or less careful users.

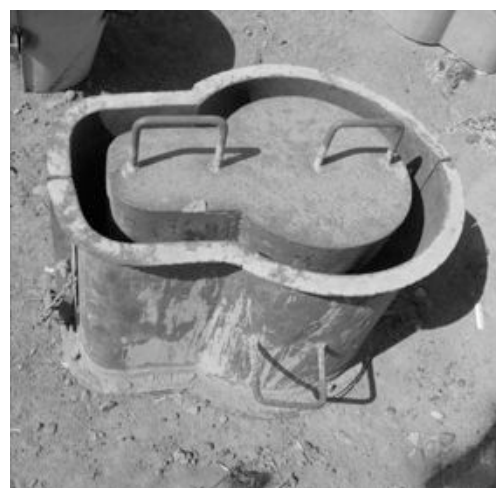
Figure 6.37 The mold built by WaterAid for fabricating the cement latrine seat for the visually impaired.

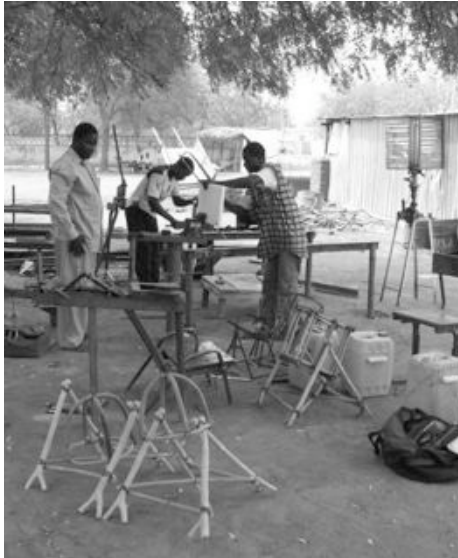
Figure 7.1 A metalworker in Tominan, Mali trains his assistants in aspects of plastic welding, metal container tipper fabrication and the placement of metal pivot sheaths in wooden container tippers. Provision of resources to assist artisans to develop prototypes and to become proficient in fabrication processes of assistive devices can be an important aspect of WASH programs seeking to make such technologies available in local markets.

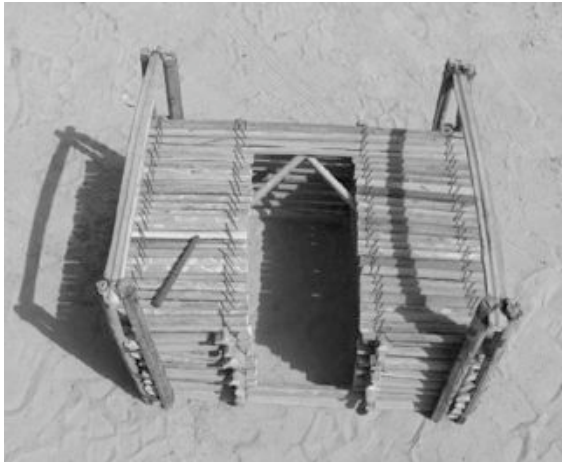
Figure 7.2 Raw material and local craftsmanship may vary from region to region in West Africa. Local artisans in the Zinder area of Niger developed this initial latrine seat prototype using dried palm branches and wire.

3. Wood workers/artisans – As with the metalworker, the same type of assessment should be made in the search for local wood artisans who can assist with developing low-cost, wood versions of these assistive technologies. It should be remembered that these are not “carpenters”, but traditional wood workers with indigenous experience in developing local household items (e.g., chairs, tables, stools, beds, etc.) from local resources. Local material, which is used in their craft, should also be examined carefully. The type and the treatment of local wood products may vary greatly from region to region. Selected wood artisans will need to be innovative in reproducing assistive technologies with local products that may have very different properties from the products used in the original technologies. For example, wooden latrine chairs in the Tominian area of Mali were made using a traditional process of steamed, bent branches cut while still green from the forest (e.g., figure 6.27). In eastern Niger, such branches are not available – only the straight, unbendable sections of palm branches which are traditionally used to fabricate local furniture. Artisans in Niger attempted to replicate the latrine chair from Mali (figure 6.27) using only these straight sections of palm branch. The result is seen in figure 7.2. This is a reasonably functional model as a first prototype, and with continued innovation and

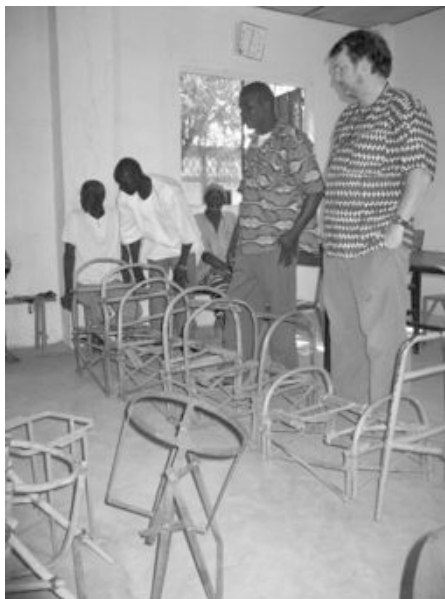
Figure 7.3 A range of latrine seats and container tippers are presented at a day-long meeting between a local “association of handicapped persons”, local artisans, and Study staff. The purpose of such meetings is to encourage and facilitate the exchange of ideas between disabled clients and those fabricating assistive devices locally.

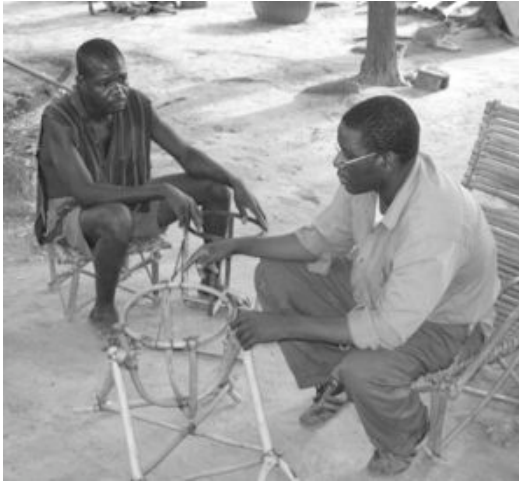
Figure 7.4 A wood artisan and metalworker from the Tominian area in Mali confer on aspects of fabricating both metal and wooden versions of a bucket tipper.

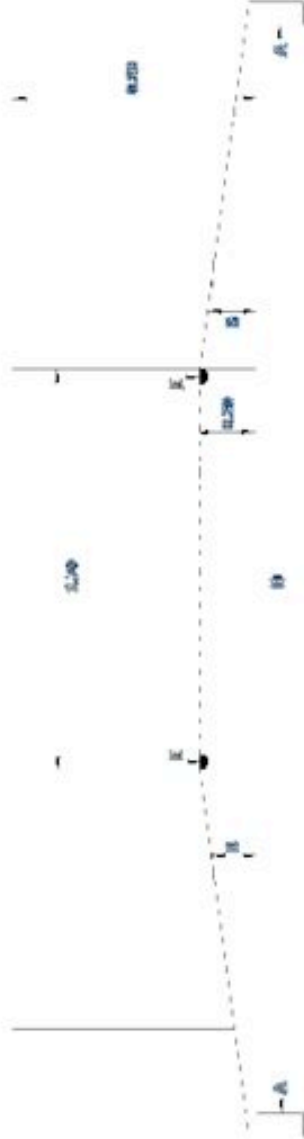
APPENDIX 1 PUMP SUPERSTRUCTURE

- A. Foundation for ramp
- B. 45° ramp slope
- C. Floor is slightly elevated from the low wall to the drain at 45° slope
- D. Design does not include foundation
- E. 2.5m elevation for tie to vehicle
- F. Drainage pipe under platform wall should extend between drain and drain from the wall
- G. Station drainage channel located against wall (from design)

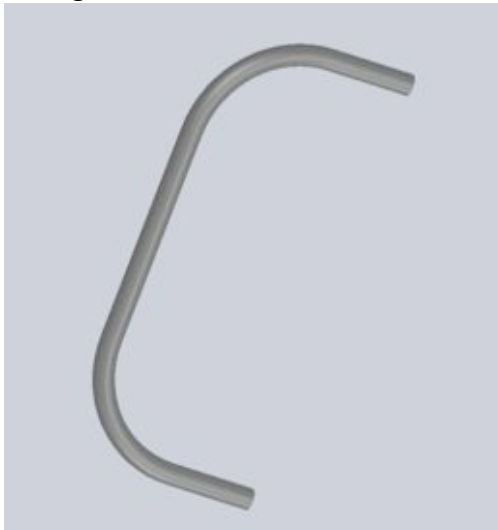
Cut off the end with extra material at point E.

See figure below.
